## **URGENT FIELD SAFETY NOTICE**

### **Information about the recommended set up of the RAPID C-Spine Coil**

Product Name : OASIS

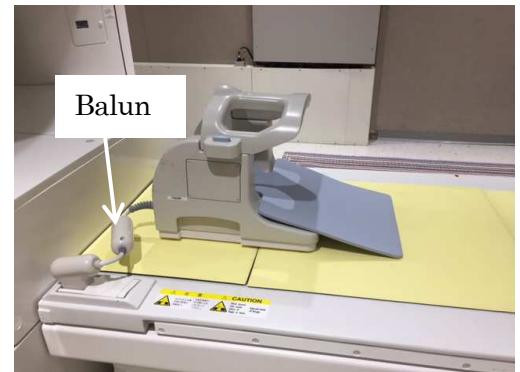
Fig.1 Balun of the RAPID C-Spine coil

Hitachi had discovered that under rare circumstances, the balun attached the RAPID C-Spine coil cable can be overheated. Although there is no the suffering health harm at that time, it is possible to suffer the health harm depending on the degree of the heating surface temperature on balun cover.

Hitachi will be implementing a corrective action to replace the RAPID C-Spine Coil cable balun with an improved version.
