CH-3110 Münsingen, March 27, 2017

FIELD SAFETY NOTICE

PREVENTIVE CORRECTIVE ACTION CONCERNING SCHAERER ARCUS 501-701 SURGICAL TABLES

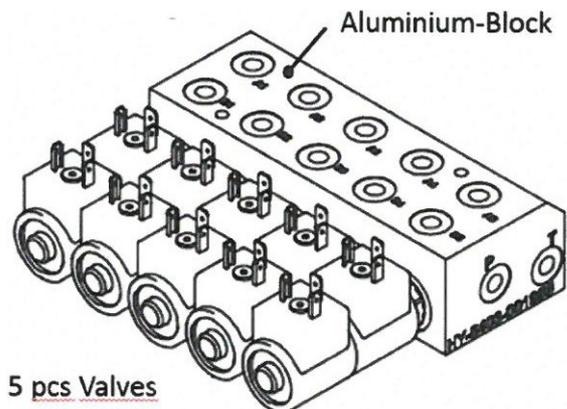
Figure 1: Large Valve Block arcus

During routine quality control procedures of the large valve block at the supplier's factory, inaccurate, out of spec drill holes were discovered. The drill holes serve as positioner for the hydraulic valves, which control the flow of hydraulic oil through the hydraulic system and thus the movements of the components of the table, such as height column, lateral tilt, Trendelenburg, seat section and leg section.

The inaccurate drill holes may result in damage of the valves, which may result in malfunction of the table. Damaged valve sealing may result an uncontrolled flow of hydraulic oil which may result in a loss of pressure in the hydraulic tubes and subsequently the cylinders are not controlled correctly

Every customer will be contacted by the Schaerer Medical Customer Service and the affected large valve bleeks will be replaced/ exchanged. Please keep this FSCA Information on file at least until the measures taken are fully completed.

Schaerer Medical will provide replacement parts and instructions for the replacement. Please contact the customers according to the serial numbers and ensure the replacement of the large valve bleeks in due course.

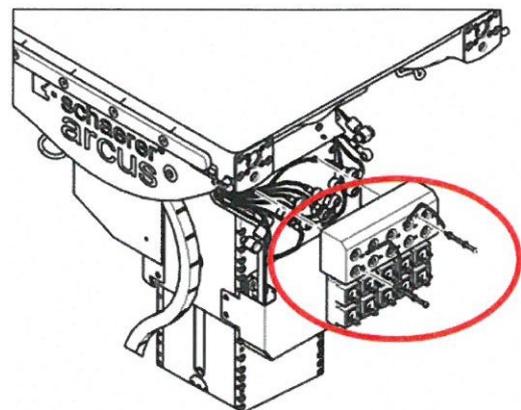
Figure 2: Position of Valveblock inside the table at the top end of the column
