Urgent Field Action Notice for Instrument ASP6025

ASP6025 Tissue Processor

Serial Numbers: 163, 169, 200-821, 823-895, 897-899, 901-1123 (all odd - serial numbers)

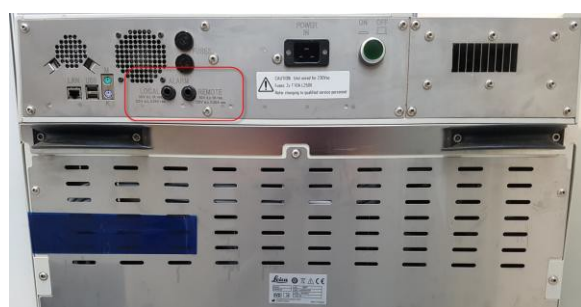
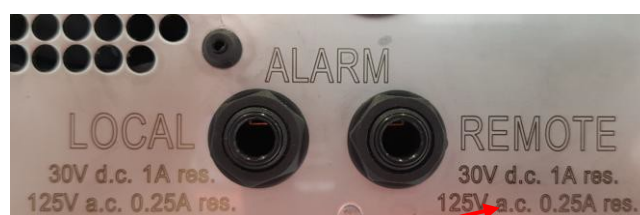
Alarm Connectors labelling

The affected devices mentioned above have incorrect labelling with regard to the specified voltage for the Alarm Connectors on the rear side of the instrument (please refer to the pictures below).

The current incorrect labels specify 125V a.c. as maximum voltage. It has been identified, that if somebody connects such 125V a.c. to the 6.3mm stereo jack, there would be hazardous voltage accessible on the plug which could lead in the worst case to a serious electrical incident.

As an immediate action, we ask that you to first clean the surface around the Alarm Connectors (grease free). Then remove the provided adhesive label (1) from the foil and place it at the Alarm Connectors as shown in the pictures below. The engraved specification must not be readable anymore!

As outlined on the new label, the maximum voltage that can be applied to the Alarm Connector is 30V DC/AC. In case you do not use the External Alarms no further immediate action is necessary. For ASP 6025 Tissue Processors where the external Alarm is used, please ensure that the maximum voltage is not exceeded by the connected external device.

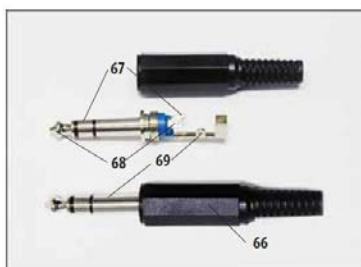
Fig. 63

In addition, the current specification in the Instruction for Use (IFU) has an incorrect labelling with regard to the specified voltage for the Alarm Connectors (please refer to the pictures below).

Each alarm is connected to the plug (66) as follows (Fig. 63):
