Urgent Field Safety Notice

SBN-CPS-2017-015

cobas c 501/502 operator injury on USM cover 3

Product Name	cobas c 501 module cobas c 502 module
Affected Instrument Part GMMI / Part No	USM cover 3 GMMI 05400937001
Instrument/System Affected	cobas c 501 module (GMMI 04745914001) cobas c 502 module (GMMI 05964067001)
SW Version	Not related to the software version
Type of Action	Field Safety Corrective Action (FSCA)

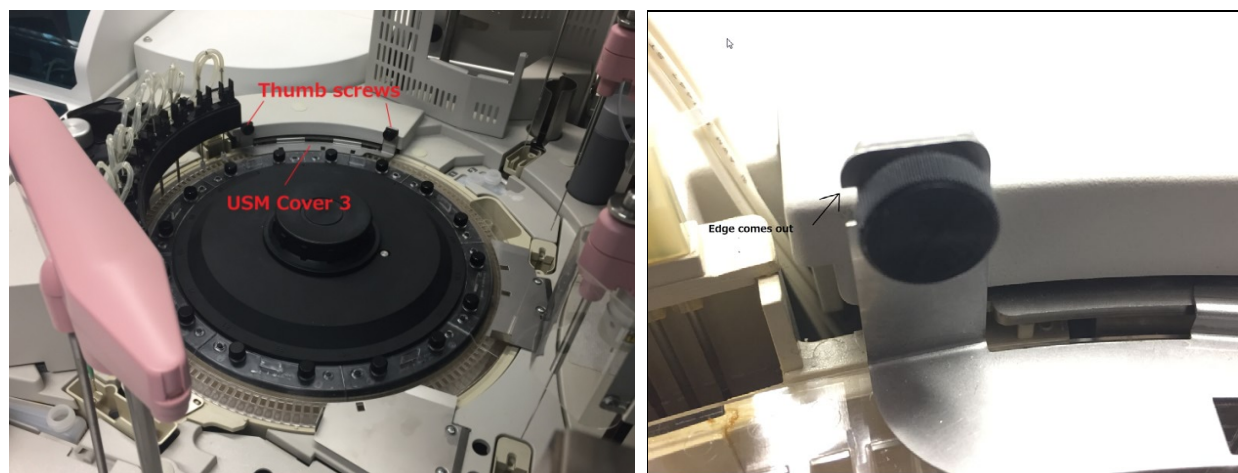
1. The operator was performing monthly maintenance to clean the incubation bath and replace cuvettes on a **cobas c** 502 module.
2. As a preparation step, thumb screws were being loosened to remove the USM cover 3, as illustrated below.
3. When the operator gripped the left thumb screw and tried to loosen it, she felt pain on her left thumb and found that it was already bleeding.
4. Her thumb was injured by the 90 degree-edge of the USM Cover 3, which is shown on the following picture.

Although the sharp edge of the USM Cover 3 is clearly visible, a medical risk due to an injury cannot be excluded.

A warning will be added to the respective Operator Manuals, which will be available by December 2017.

Customers are advised not to overtighten the thumb screws when replacing the cover after maintenance. When removing the screws for maintenance **avoid** touching the edge of the USM Cover 3.
