# Field Safety Notice, Medical Device Correction #20673

# RayStation 6 (including SP1 and SP2) July 14, 2017 RSL-D-61-337

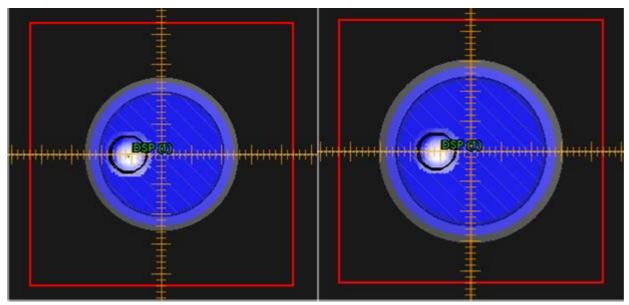
This means that the physical size of the block and compensator used for dose computation in the RayStation QA plan changes, and consequently the dose in the QA module may be computed for a physical block and/or compensator setup that differs from the setup that was specified in the treatment plan and used for QA measurements.

Fig. 1: BEV showing Snout position (i.e. the isocenter to snout position plane distance) = 20 cm (Left) vs Snout position = 50 cm (Right).

Snout is moved relative to the isocenter and the block/compensator geometry at isocenter is maintained, resulting in a change of physical block/compensator size in the QA plan.

- Do not modify Snout Position or Gap for proton QA plans with block and/or compensator.
- If the air gap needs to be adjusted in the QA plan to avoid collision with the phantom, edit the Isocenter position. This will preserve the block and compensator geometry in RayStation to match the block and compensator geometry that was manufactured according to the treatment plan.
