Urgent Field Safety Notice

SBN-CPS-2019-009

Damaged assay cups in two lots of AssayTip/AssayCup Combiracks

Product Name	AssayTip/AssayCup
GMMI / Part No	12102137001 / Lot #: 19817113 and 19818113
Device Identifier	
Instrument/System Affected	cobas e 601 module cobas e 602 module MODULAR ANALYTICS E 170 MODULAR ANALYTICS EVO E combinations
SW Version	Not applicable
Type of Action	Field Safety Corrective Action (FSCA)

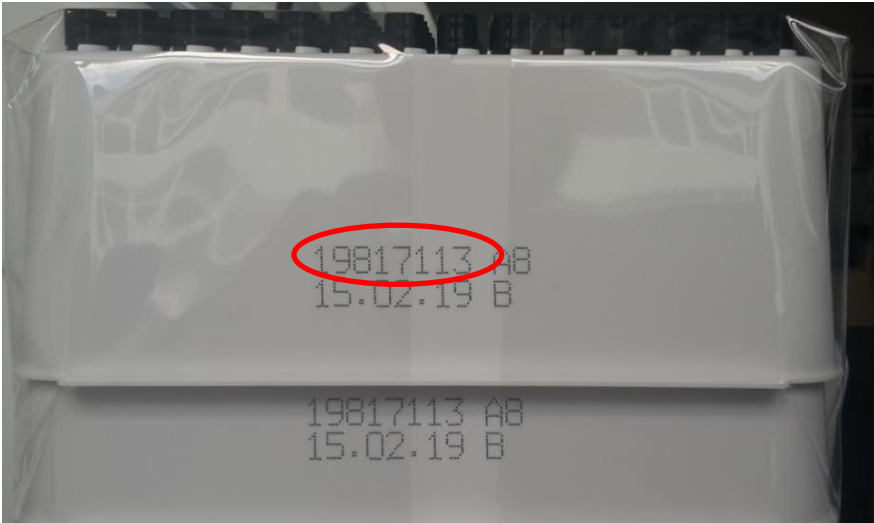
Figure 1: Example of a lot number printed in the AssayTip/AssayCup CombiRack tray

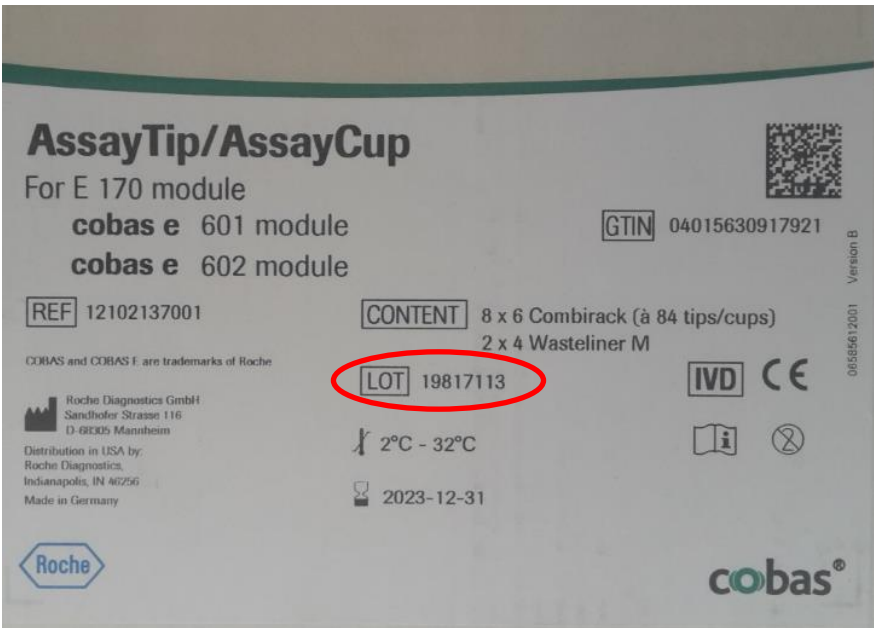
Figure 2: Example of a lot number printed in the AssayTip/AssayCup CombiRack box

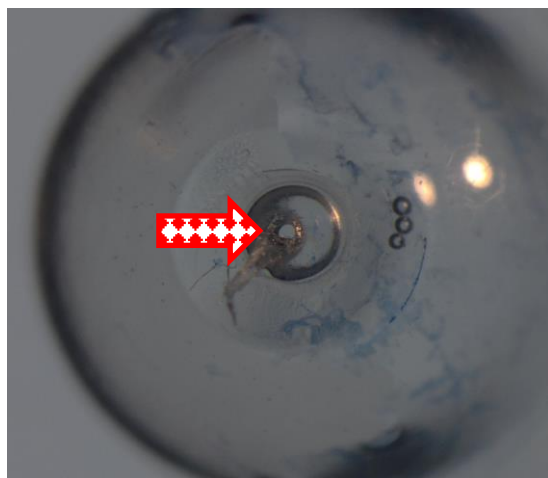
The defect consists of a small hole at the bottom of up to 3% of the total amount of Assay Cups produced in lots 19817113 and 19818113. The affected products represent 0,06 % of the yearly production of this product (GMMI 12102137001).

Figure 3: Example of a damaged AssayCup with the small hole at the bottom, which can only be seen with magnifying glasses. The small hole is marked by the red arrow. Blue colored water and the three water droplets next to the small hole are the result from previous investigations.

This issue was caused by a partial blockage in two out of 32 cavities used in the production of the AssayCups for a short time. An immediate corrective action was taken in order to avoid recurrence of the issue. No other lots were affected.

- Customers must check if they received AssayTips/Assay cups from one of the lots: 19817113 and 19818113.
- Customers must stop using the affected AssayTip/AssayCup lots.
- AssayTips/AssayCups from the affected lot numbers must be discarded locally and replaced by different lot numbers. Customers are advised to also check the lot numbers of the trays placed in the instruments.
- In case patients' results were released using those two lots, appropriate patient re-testing may be advisable, taking into account patients' medical history and clinical examination.
