SOMATOM Force
SOMATOM Definition AS
SOMATOM Definition Edge
SOMATOM Definition Flash
SOMATOM Drive
SOMATOM Confidence
SOMATOM Edge Plus
with software *syngo* CT VB10A

Customer Safety Advisory Notice CT035/19/S

Subject: Potential safety related software issues in *syngo* CT VB10A software running on several types of SOMATOM CT scanners - Potential safety related issues solved in *syngo* CT VB20 software

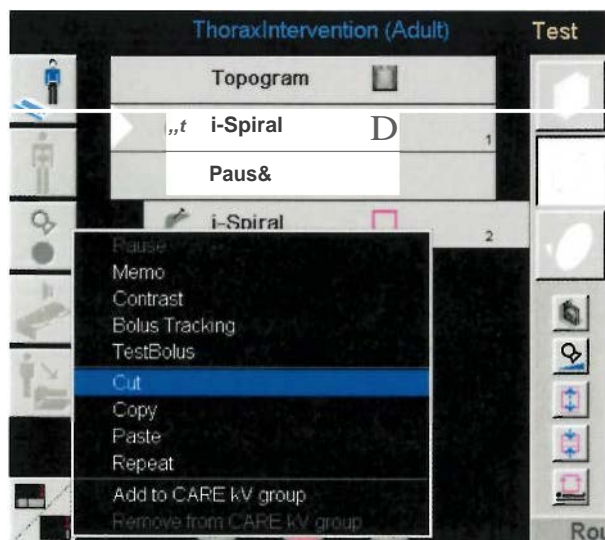
- 4.) The systems may sporadically crash during an interventional workflow using the cut functionality. Details: This issue can happen when the following conditions are fulfilled. An Intervention examination is already started and an i-mode (i-spiral, i-sequence, i-fluoro) is loaded. In this situation the chronicle context menu option <Cut> will lead to a software crash. For details see Fig. 1 below.

Fig. 1: Example of how issue 4 may occur.

- 3.) The series description changes unexpectedly: To avoid this highly sporadic issue, the operator should check the series description for any unexpected changes after the scans have been completed and before the recon jobs are started. It can be changed back manually if the recon has not yet started.
- 4.) Crash during interventional workflow: After the software crash, a system restart is needed. To prevent this happening, the loaded Intervention examination has to be canceled (press <Cancel> button) before a chronicle entry is cut.

These issues will be resolved with the next *syngo* CT VB20 software version. Its release is planned for Q4/2019.

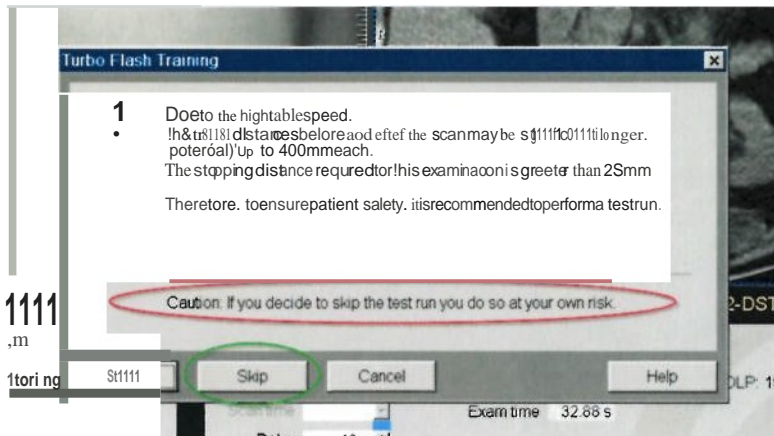
- 2.) For SOMATOM Force users only: When planning a "Turbo Flash" spiral scan, the examination task card may lock up. This can occur if a "Care Contrast" scan contains a pre-monitoring scan, a contrast sequence monitoring scan and a "Turbo Flash" spiral scan with a high pitch (>2.3).
Details: After the pre-monitoring scan, the operator selects a ROi and clicks <Accept>. Due to the high pitch (or the high table speed) of the "Turbo Flash" spiral scan, a table test move is proposed to the operator. After clicking <Start>, the system issues a request to press the <Move> button. When the <Move> button is pressed, nothing happens but the table test move dialog pops up again. The exam task card then locks up, if the <Start> button is pressed a second time.

Fig . 2 : Table test dialogue with warning if skipped

- 2.) The examination task card may look up during a "Turbo Flash" spiral scan. In order to avoid such a look-up, two solutions exist:
 - a. The pitch can be reduced so that the table test move becomes obsolete and is not proposed to the operator any more. This consequently means the examination is no longer a real "Turbo Flash" spiral scan.

- b. The table test move is not a must and can be skipped. If this workaround is chosen, the operator must be particularly cautious and make sure that there are no obstacles in the way of the table top movement. The high table top speed during such examinations makes it impossible to stop the movement within the usually required 25 mm. The travel distance before and after the scan may be up to 400 mm. The corresponding dialog is shown in Fig. 2 below.
