Urgent Field Safety Notice

**Ambu AuraGain
December 9, 2015**

Ambu® AuraGain™ - Single Use Laryngeal Mask - Sterile

Lack of Sterility Assurance.

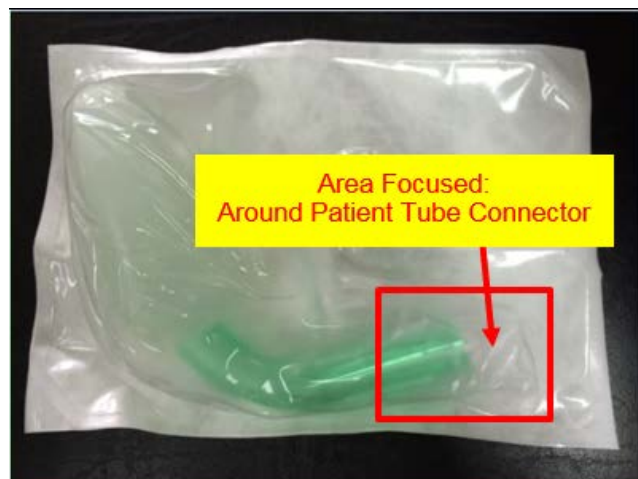
Step 1:

The cause of the potentially compromised sterile barrier is a small hole in the transparent film. Please see picture to the right, for a visual specification of the area to inspect.

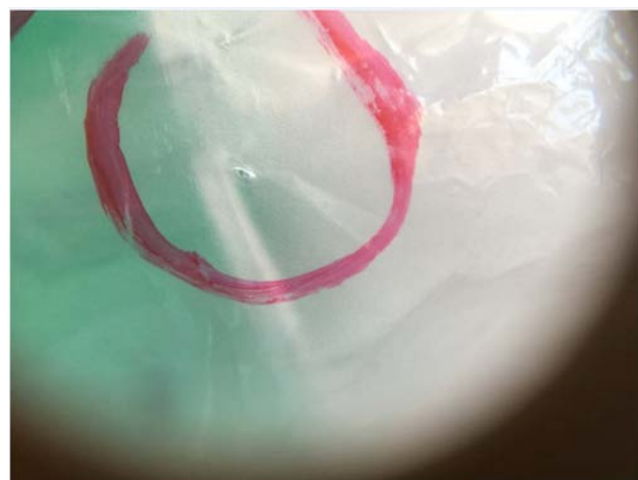
Step 2:

The inspection should be carried out in a setting with good light, to support best possible identification of breach. The breach is associated with a mark in the transparent film. If a device has a mark like illustrated on the picture to the right, it should be discarded. If in doubt whether a specific device has a hole, please discard.

Discarded devices should be collected and quarantined. Information on discarded devices should be kept and filled into appendix 3.
