Risk Assessment and Health Hazard Evaluation	
Risk Assessment ID and Revision	RA2016-000029
Description	Robot can automatically move to perform Laser Alignment Check as soon as accessory contact sensors are cleared.
Product Line or Process	CyberKnife
Affected Sub-System(s) & Version(s)	CyberKnife Treatment Robot
Risk Assessments and Version(s)	CK-PRMR-1061, Revision 1 31 MAR 2015
Associated Documents	
Complaint Case Number	C036023
Anomaly Number	42724 Also associated with Anomalies 31339, 33363, and 42668
Service Order Number	N/A
Other	N/A

Summary of the Potential Safety Risk issue

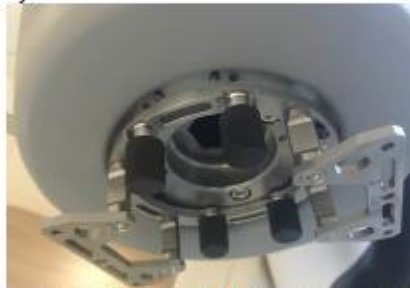
A user left the birdcage accessory mount (not the birdcage itself) on the robot. The user then loaded a treatment plan that required the accessory mount to be attached to the robot, but also required the system to first require a Laser Alignment Check. The user went to the Couch phase in treatment and noticed the message "Manual action required: Accessory mount attached to robot, please remove." The user also noticed that the LAC button was blinking and clicked it to make sure no robot motion was going to occur. The user then proceeded into the room to remove the accessory mount from the robot. As soon as the connection sensor for the accessory mount was released, the robot initiated the latent user request to perform a laser alignment check and started its motion.

Robot Treatment Head with accessory attached

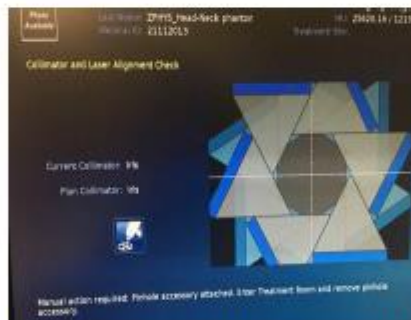
Treatment Console Display with message at bottom of screen to remove accessory

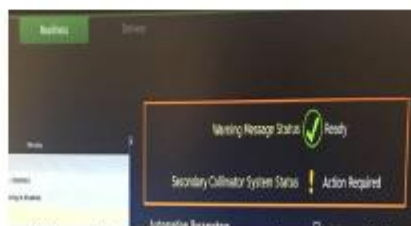
Treatment Console Display with confirmation message that was clicked by user prior to accessory removal

In addition, from review of the CyberKnife Treatment Delivery Guide P/N 1048119, the section detailing "Checking Equipment Readiness" pages 7-71 and 7-72 does not advise that the condition reported in the Warning Message should be addressed prior to clicking the "Confirm" screen button. This issue has been logged as anomaly 42868.

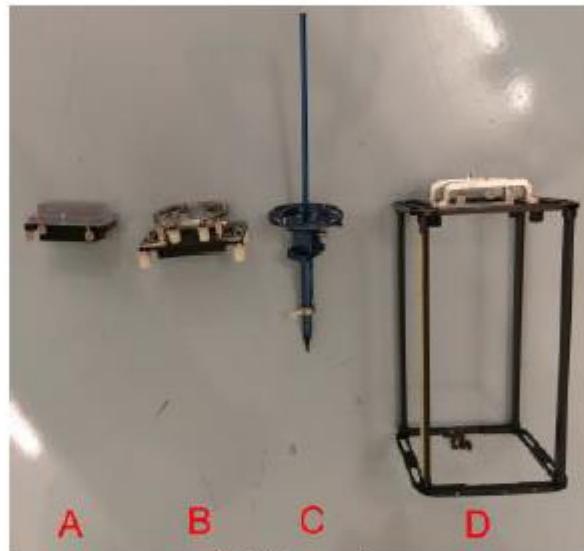
Robot Accessories

The accessories that can be mounted to the robot include the Small Film Holder (A in diagram below), Pin Hole (B in diagram below), Pointer (C in diagram below), and Birdcage (D in diagram below).

The Pin Hole (B) and Birdcage (D) accessories require connection to accessory mounts (attached in the picture above) that then are secured to mounting holes on the robot. The Small Film Holder (A) and Pointer (C) mount directly to the mounting holes on the robot. Based on the experience of service support, it is typical for users to detach the Pinhole and Birdcage accessories by detaching the accessory mount directly from the robot mounting holes, instead of first removing the birdcage from the accessory mount and then subsequently detaching the accessory mount from the robot.

The Small Film Holder and Pinhole accessories and the Birdcage accessory mount have low enough profiles that they will not contact or pinch against the exchange table in a manner that should risk injury to personnel. The Pointer and Birdcage accessories have longer profiles and could be driven against the side of the exchange table.
