Urgent Field Safety Notice

Problem Description

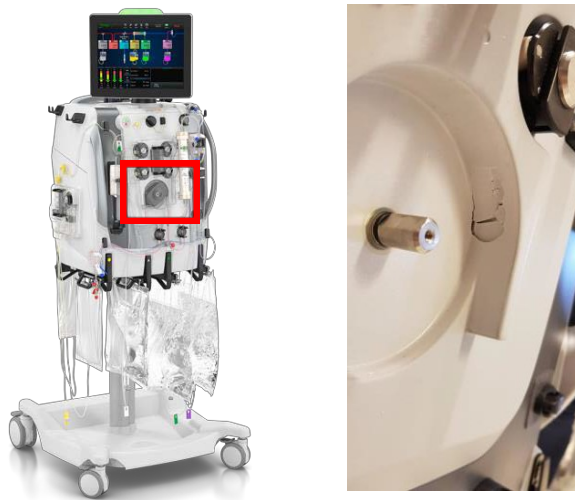
Baxter Healthcare has identified the potential for certain PrisMax devices to develop cracks in the blood pump raceway over time (refer to figure 1). The cracks are caused by varying material thickness in this specific area of the front panel. To ensure high quality, and to avoid any problems with the front panel over time, the front panel will be replaced on all potentially impacted units listed in the affected product table below.

Figure 1: Pictures of PrisMax device and cracks in the blood pump raceway

A crack in the blood pump raceway is likely to cause insufficient occlusion of the blood pump. If this occurs before treatment, the device will no longer pass the prime test. If this occurs during treatment, therapy will be interrupted. A device affected by this failure will not be usable until an off-site repair by Baxter Service is completed.

1. Operators may continue to safely use affected devices that have not exhibited failures of the blood pump raceway. If the device is not performing as intended as a result of this issue, the user will be alerted by Alarm T0850, Alarm T0525, or Alarm T0602.

2. A local Baxter service representative will contact your facility to determine the correction plan and schedule the off-site device repair. Loaner devices will be provided as needed. If you experience an alarm, please contact Baxter Technical Service at **(to be adapted locally)**.
