Urgent Field Safety Notice

Prismaflex Control Unit FA-2019-050 Device Correction

October XX, 2019 (to be adapted locally)

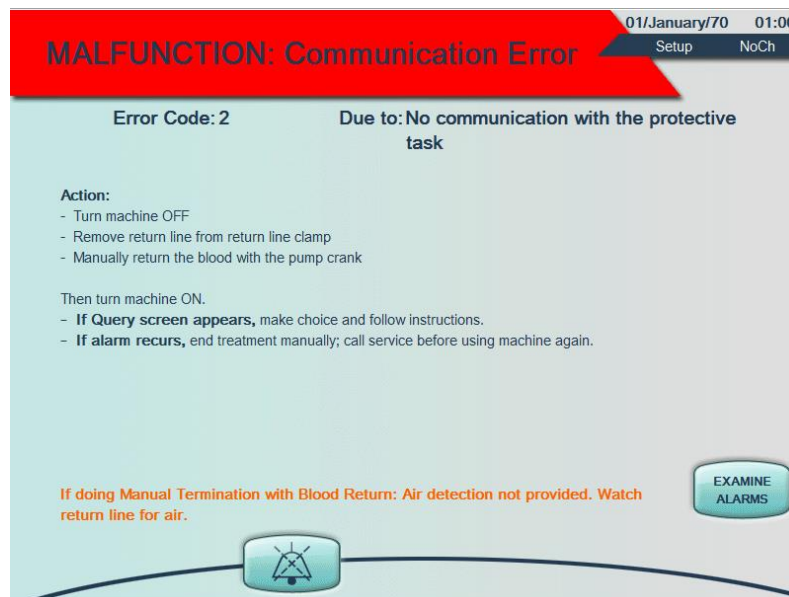
The following actions occur during a communication error alarm:

- The Prismaflex control unit enters a “safe state” by stopping all pumps and closing the return line clamp. Treatment is suspended. The patient’s blood does not circulate through the blood flow path.
- Red flashing light
- Recurring high-pitched sound of 10 sound pulses repeated approximately every 8 seconds until muted.
- Malfunction screen appears on the display as pictured below. The instructions to the user are the same for all error codes.

1. Operators may continue to safely use the Prismaflex control units until the upgrade is performed. If a communication error alarm does occur, follow the instructions presented on the graphical user interface and/or in the operator’s manual. Please reinforce the importance to manually return the extracorporeal blood to the patient, and re-train users on this process, outlined on page 10:57 (to be adapted locally) of the operator’s manual, if necessary.
