Urgent Field Safety Notice

O-arm™ O2 Imaging System

November 2019

Medtronic reference: FA895

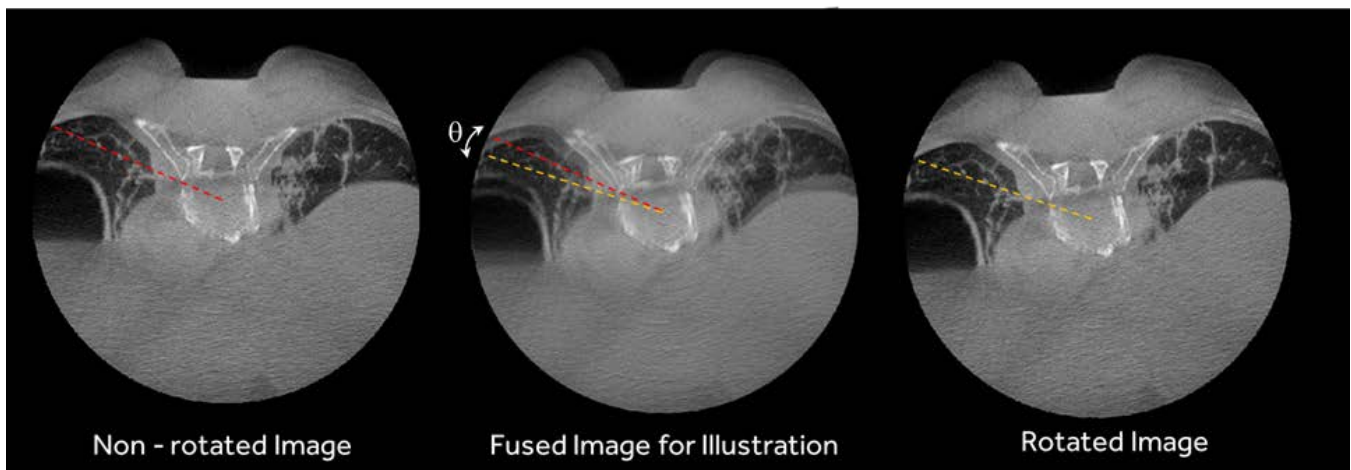
Medtronic has determined through internal testing that there is a potential for navigational inaccuracy when utilizing the O-arm™ O2 Imaging System's auto-registration feature, when used in conjunction with an Image-Guided Surgery System for a specific set of O-arm™ O2 Imaging System serial numbers. A list of potentially affected systems is provided in Table 1 of this letter. Due to loosening of an internal motor drive belt over extended number of uses, image rotation may occur relative to patient positioning data. Inaccuracy may occur when the O-arm registration information is transferred to an Image-Guided Surgery System to be used in navigation, utilizing the rotated images.

Navigational inaccuracies are inherent in the use of any Image-Guided Surgery System utilizing an O-arm™ O2 Imaging System, but the potential for inaccuracy may be higher if image rotation occurs in an affected system. This letter provides awareness of this issue and reinforces existing instructions within the O-arm™ O2 Imaging System User Manual (IFU) that allow for identification of the issue if it occurs. This issue does not involve the O-arm 1000 Imaging Systems.
