Customer Safety Information (CSI) for Field Safety Corrective Action:

AX028/20/S

Subject: Customer SafetyInformation concerning the repair of the x-ray generator Polydoros M25 revision 04 which is included in certain Cios Spin & Cios Alpha systems.

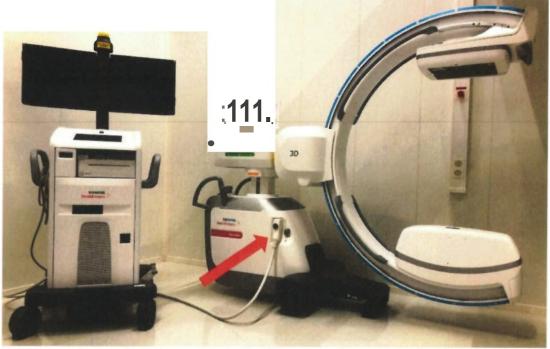
During the operation of the Cios system the monitor trolley of the Cios system is electrically connected with the main unit (c-arm) of the Cios System by a main cable. The main cable can be pluggedor unplugged trom the XIO connector which is part of the main unit (c-arm) at any t ime during clinical session (see figure 1 and 2). The unplugging of the main cable can cause an unsafe electrical voltage (up to 67,6 V DC) at the XIO connector which can result in an electrical shock if the user or other persons touch the contact pins of the XIO connector. These contact pins of the XIO connector are accessible when the main cable is unplugged from the XIO connector (see figure 2 and 3).

figure 1:example of monitor trolley connected to the XlO connector of themain unit (c-arm) bymain cab/e

We strongly recommend to not unplug the main cable until the generator is repaired by a service engineer.

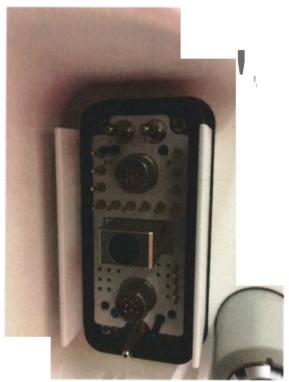
figure 3: example of XIO connector without the plug of the main cobiebeing plugged in

There is no impact to the operation of the system but there is a danger to health of the user or other persons due to the above described risk of an electrical shock when the main cable is unplugged and the user or other persons touch the contact pins of the XIO connector.

A service engineer will repair the generator of your affected system at your site.

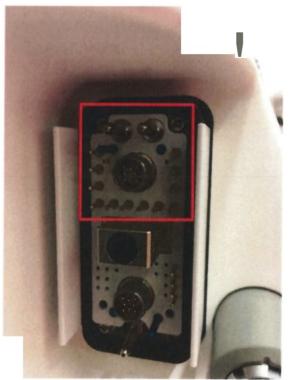
figure 2: example of XIO connector contact pinarea which mustnotbe touched

The problem was identified by the manufacturer during system assembly when the plug of the main cable was unplugged. The root cause is a design flaw in a generator component of the generator Polydoros M25 revision 04.
