## **Urgent Field Safety Notice**

## Update to address Numerical Format Issue in the CT900 Clinician Programmer via Model A810 SynchroMed<sup>™</sup> II Software Application for Version 1.1.342 Software Update

Medtronic Reference: FA920

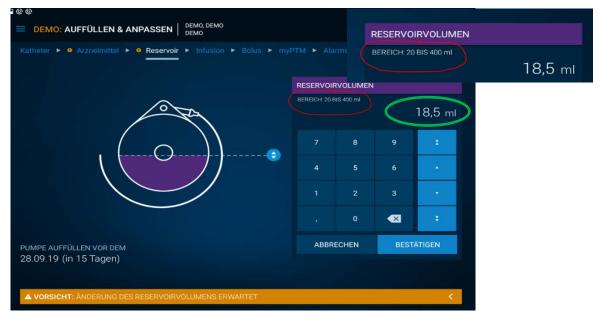
Figure 1: Incorrect values displayed for the allowed range of the reservoir volume (200 – 400 ml): Data entered by HCP is correct (18.5 ml)

Please download the latest update to the A810 SynchroMed II Software Application, version 1.1.342, to the CT900 Clinician Programmer following the enclosed instructions.

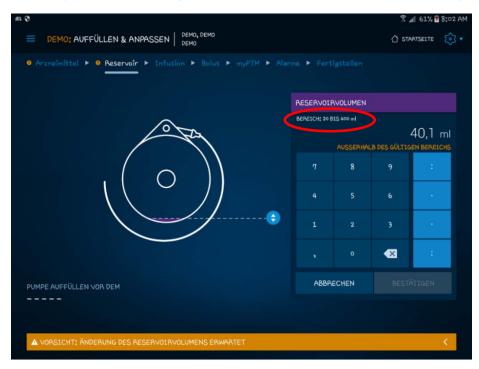
Figure 2: Value 40,1 cannot be entered even though the displayed range text indicates it can
