Date: 2020-12-04

## <u>Urgent Field Safety Notice</u> <u>Tourni-Cot Universal – "Uni-Cot"</u>

FSCA Ref: MM-FSA-01

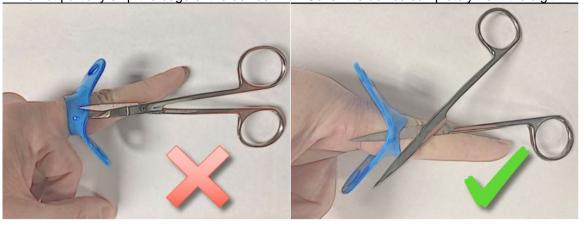
- In rare instances, the device may split into two pieces during removal leaving a portion of the device on the patient's digit. If a portion of the device is in place, it will continue to constrict blood flow to the digit resulting in ischemia. This split can occur when removal is attempted by making a partial snip at the edge of the device and then pulling the device from the affected digit, leaving a constricting band on the patient. Removal of a portion of the device may give user the false impression that the entire device was removed if not observed with care.

Do not partially snip the edge of the device. Sever the device completely from the digit.

The manufacturer believes that this failure can be largely mitigated by following standard best practices for the use of tourniquets, specifically by reviewing the affected digit for complete removal of device prior to completion of the procedure. See images below for guidance:
