Cressier, 22nd December 2020

Field Safety Corrective Action / FSCA 004-20

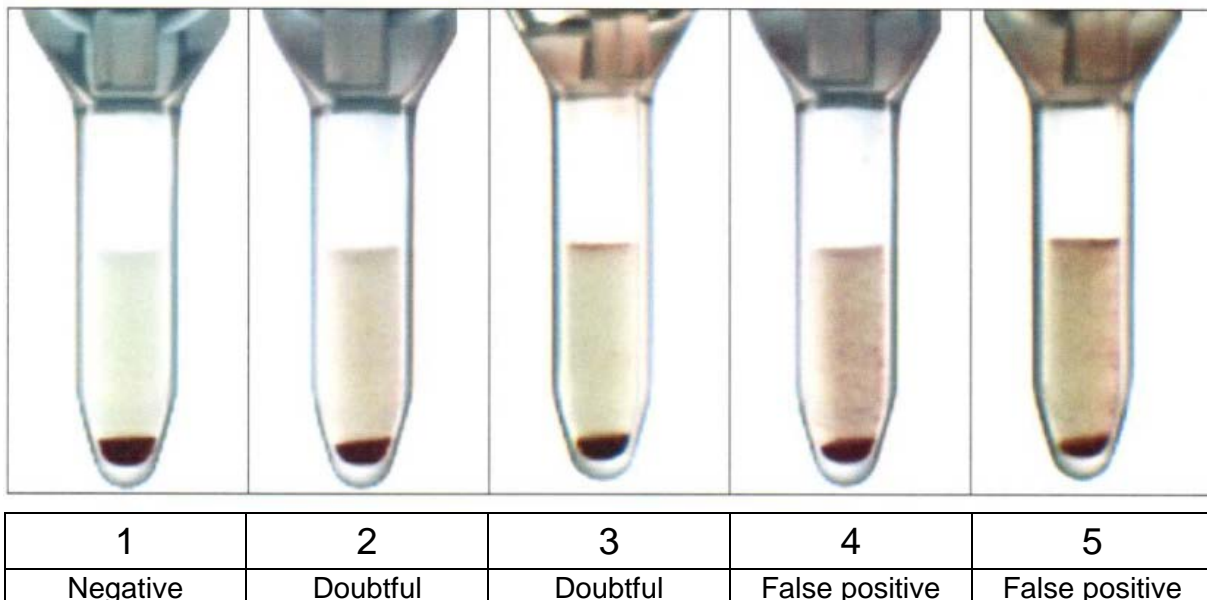
The root cause for both these phenomena is highly suspected to be related to the type of glass vials used in the manufacturing of reagent red blood cells.

The first phenomenon concerns nonspecific reactions primarily observed on QC samples but also with patient samples and eluates. Doubtful reactions or in some cases false positive reactions may occur randomly between batches and within a same batch. This phenomenon can appear with both manual and all automated methods.

The following are examples of the type of image that can be seen when the phenomenon occurs (image 1 in Figure 1 shows a normal negative reaction for comparison). These nonspecific reactions vary from doubtful (images 2 and 3) to positive (images 4 and 5) as shown in the figure 1 below.

Figure 1_ Example of nonspecific reactions observed in IAT

The analyzer (Banjo ID-Reader, Saxo ID-Reader II, IH-1000, IH-500 or Classic ID-GelStation) may interpret a “?”, “wR”, “wF”, or “DP” (image 2 and 3 in Figure 1) or any option up to ++ (images 4 and 5 in Figure 1), depending on the intensity of the reaction.

In case you are facing the **nonspecific reaction** during the result validation (referring to figure 1), we recommend to:

1. Invalidate the result,
2. Repeat the test using non-open vials of the same lot,

3. Repeat the test with using a kit of a new lot,

4. Use an alternative method.

If you work with the automatic validation activated, we recommend the visual confirmation of all positive results of indirect antiglobulin tests.

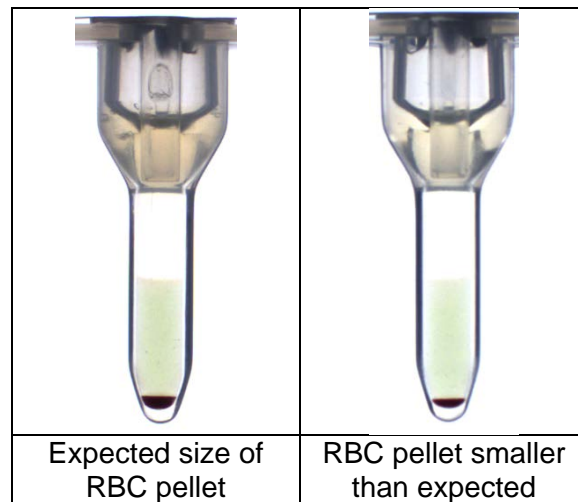
The second phenomenon concerns insufficient homogenization of the red blood cells within the vials when stored on-board either on the IH-500 or on the IH-1000 and when the remaining volume reaches 2ml or lower. This lack of homogenization can lead to a dispense of low-concentrated red blood cell reagent into the wells of the ID-cards.

The following are examples of the type of images (Figure 2) that can be seen with small pellet compared to a well with expected red blood cell amount.

Figure 2_ Example of small pellet observed with insufficient red blood cell homogenization

The **insufficient homogenization** leading to smaller pellets in the microtube occurs when the remaining volume of the reagent in the vial decreases.

If you detect smaller pellet than expected during the result validation (referring to figure 2 or comparing with other available result), we recommend to:

1. Invalidate the result,
2. Unload the reagent, swirl it gently to homogenize the reagent and load it back in the instrument,
3. Repeat the test,

4. Retest with a non-open vial

To prevent this phenomenon, particularly if you are operating under the automatic validation of the results, we recommend resuspending manually the red blood cells at least every hour by gently swirling the vials, when the remaining volume has reached 2 mL or lower.
