Customer Advisory Notice CT057/20/S

Subject: Technical issue with several SOMATOM CT scanners running on *syngo* CT VB20A_SP2, solved with the new service pack VB20A_SP3

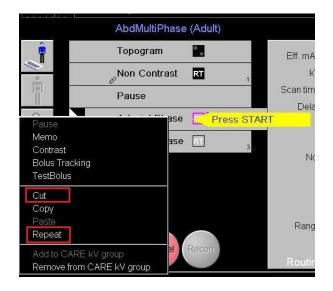
Fig. 1: Context menu (right mouse click) offering the functions "Cut" and "Repeat" of a scan selected in the chronicle

In this situation it may be the case that the system will no longer accept any potential change to a scan or reconstruction-relevant parameter. Erroneously the changed parameters are displayed in the graphical user interface, but in fact the previous settings remain unchanged. Consequently, the original parameters will be used for the scan already loaded when the X-ray generation is started.

As the root cause, we found that the system does not trigger a cancel command followed by a reload of the scan with the new parameter(s).

Please cancel the scan already loaded **before** cutting or repeating an entry.

This issue will be solved by an improved *syngo* CT VB20A_SP3 software version. A service pack will be rolled out free of charge with the update CT056/20/S for all affected systems. Its release is planned for the end of Q4/2020. All future service packs will contain the fix as well.
