Field Safety Notice / FSCA 001-21

Affected products displaying the issue:

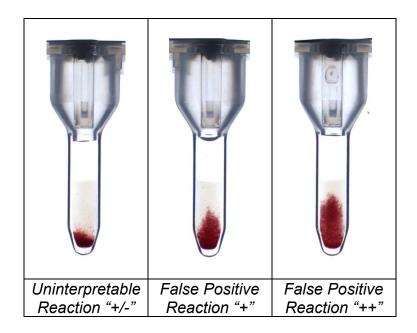
Table 1: Example of non-specific reactions obtained on IH-500 with the impacted lots of card

Following customer feedback, we confirm that non-specific reactions could be observed in the **anti-N well (MNS2)** of the above-mentioned cards with N negative samples (MNS: -2).

The table 1 shows the range of false positive reactions that may occur.

The phenomenon is observed frequently when the ID-Cards are used on the IH-500. It is more rarely observed when the ID-Cards are used on IH-1000 or tested in the manual or semi-automated methods (Saxo ID-Reader II, Banjo ID-Reader, Swing TwinSampler, Classic ID-Gelstation).

Impact on the result	There is a risk of a false positive result (up to 2+ maximum) for the typing of the N antigen when carried out with lot numbers listed above.
Risk in the context of donor typing	None as N positive blood units will not be used for transfusing a patient having a clinically significant anti-N
Risk in the context of patient typing	Delayed result - this antigen typing would be carried out for a patient presenting with a clinically significant anti-N. This inconsistency would lead to further testing.

Testing Method	Recommendation		
IH-500	1) Stop using the impacted ID-cards on the IH-500. 2) Use one of the following methods: • Manual method or, • semi-automated method or, • fully automated method with the IH-1000 analyzer, according to recommendations described below.		
IH-1000 and semi-automated methods	Deactivate the automatic validation of the results in IH-Com In case of a reaction shown as +/-, + or ++ by the instrument please follow the recommendations below: 1) Invalidate the result, 2) Repeat the test with the manual method		
Manual Method	If visual interpretation of the reaction is +/-, +, or ++ (refer to table 2): 1) Invalidate the result, 2) Repeat the test If retesting does not permit to conclude the presence or absence of the N antigen, use an alternative method such as an antigen profile determination including an incubation step at room temperature.

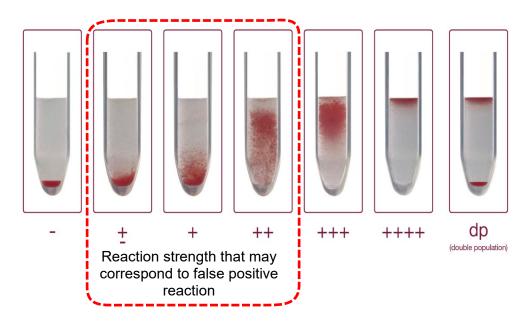
Table 2: Reading charter for visual interpretation of reaction strength

Any positive reaction obtained with the impacted lots showing a reaction strength of +++ to ++++ (refer to table 2 or instrument interpretation) should be considered as valid and indicates the presence of the corresponding antigen.
