## URGENT FIELD SAFETY NOTICE

Surgical Microscope Leica M220 F12  
FSCA Identifier: CAPA-HER-MD-21-002  
Additional Retention Fixture to secure M220 Optics Carrier

Heerbrugg, November 2nd, 2021  
Leica Microsystems (Schweiz) AG

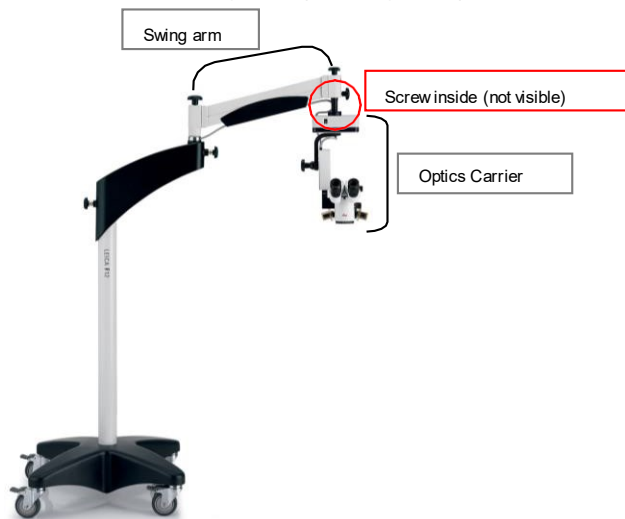
Figure 1: Leica M220 F12 Surgical Microscope

The identified defect is a mechanical part failure with the screw that connects the optics carrier to the free end of the swing arm (see Figure 1).

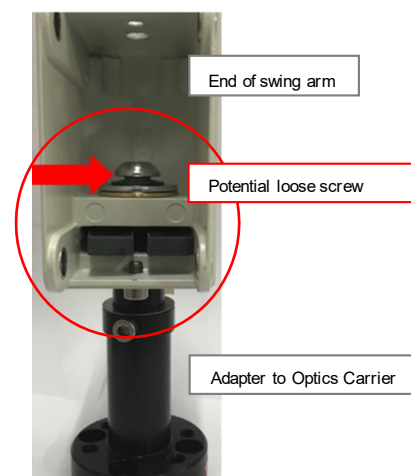
Figure 2: Potential loose screw connecting the swing arm with the optics carrier

Leica Microsystems has performed a thorough root cause investigation which has identified the cause of the observed issue to be insufficient securing of the screw that connects the swing arm with the optics carrier (see Figure 2). This screw was found to not be secured by an adequate amount of high strength thread adhesive to ensure a reliable connection of the swing arm with the optics carrier. This inadequate securing of the swing arm was not identified during production and final inspection of the M220 swing arms. These swing arms were then built into M220 F12 Surgical Microscopes manufactured before March 9<sup>th</sup>, 2017\*. Due to this, the screw that connects the swing arm with the optics carrier has loosened over time (see Figure 2) and subsequently resulted in the optics carrier falling. Based on the results of the root cause investigation the probability of occurrence of this defect for the end user is very low.

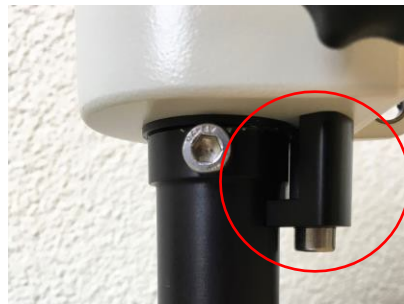
Figure 3: Detailed view of the retention fixture as an additional means of securing the M220 Optics Carrier

As a matter of precaution Leica Microsystems has chosen to initiate a field safety corrective action to provide a retention fixture (see Figure 3) to be added on all Leica M220 F12 Surgical Microscopes manufactured before March 9<sup>th</sup>, 2017 to ensure patient safety and customer satisfaction.

Your Leica Microsystems representative will provide you a retention fixture as an additional means of securing the M220 Optics Carrier free of charge.

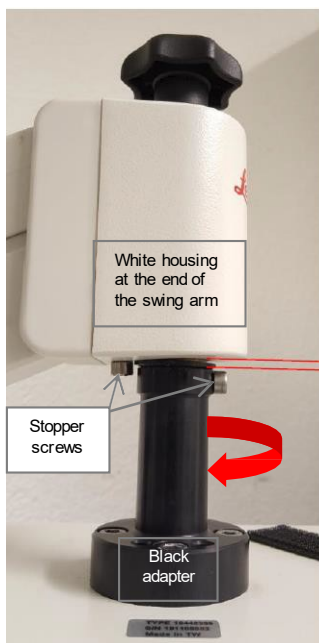
- If the gap between the black adapter and the white housing at the end of the swing arm becomes bigger than 3mm (see Figure 4) or a free rotation of the optics carrier is possible for more than 360° (see Figure 5): → **Immediately stop using the device!**

Figure 4: Detailed view of gap between black adapter and white housing of swing arm.

**X** A gap bigger than 3mm or possible free rotation of the optics carrier for more than 360° indicates that the screw holding the adapter is loose and there is a potential risk that the optics carrier becomes disconnected and potentially fall.

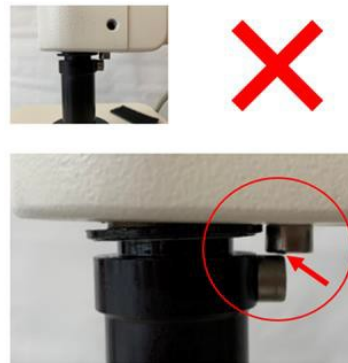
Figure 5: Detailed view of stopper screw when M220 F12 is faulty: Stopper screws are not effective and allow free rotation > 360°. → **Immediately stop using the device!** The M220 F12 can no longer be used.

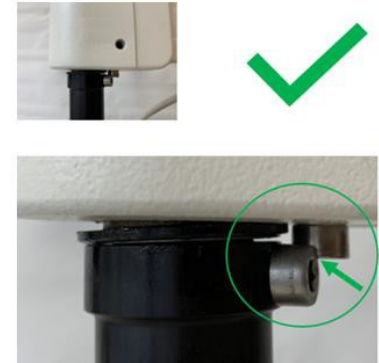
Figure 6: Detailed view of stopper screws when M220 F12 is according specification: Stopper screws are effective and do NOT allow free rotation > 360° → **Instrument can be used as intended.** There is no risk for the optics carrier to disconnect from the swing arm and potentially fall.

**✓** With a gap of less than 3mm, and it is NOT possible to rotate the optics carrier 360° the screw holding the adapter is NOT loose and the device can be continued to use as intended.
