## Urgent Field Safety Notice

### HeartWare™ Ventricular Assist Device (HVAD™) System, Model 1104

Update to failure rates and recommendations

Medtronic reference: FA944

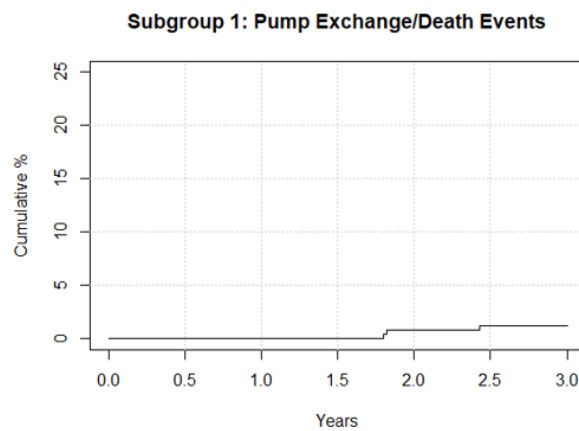
**Figure 1: Cumulative incidence of experiencing a pump stop with delay/failure to restart leading to a pump exchange or death in Subgroup 1**

- Subgroup 1 includes 316 distributed pumps manufactured from a single supplier lot of components, exhibiting 9 events of a delay or failure to restart, 2 of which involved a patient death. Our records indicate there are currently 97 patients on support with a pump from Subgroup 1.
- Subgroup 2 includes 174 distributed pumps manufactured from the 2 subsequent supplier lots of components, exhibiting 32 events of a delay or failure to restart, 8 of which involved a patient death. Our records indicate there are currently 48 patients on support with a pump from Subgroup 2.

Subgroup 1: Pump Exchange/Death Events

Year	Rate	Lower CI	Upper CI
1	0	NA	NA
2	0.8%	0.2%	3.2%
3	1.2%	0.4%	3.8%

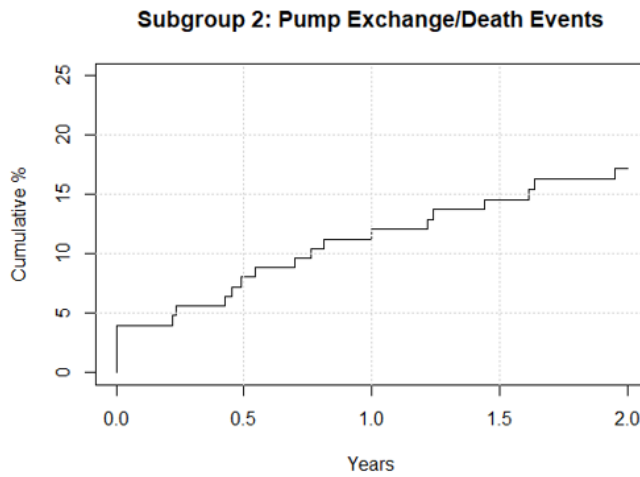
**Figure 2: Cumulative incidence of experiencing a pump stop with delay/failure to restart leading to a pump exchange or death in Subgroup 2**

Subgroup 2: Pump Exchange/Death Events

Year	Rate	Lower CI	Upper CI
1	12.1%	7.5%	19.4%
2	17.2%	11.7%	25.5%
