Field Safety Notice

URGENT PRODUCT SAFETY INFORMATION

Commercial name of the affected product: BIP O-Twist Marker SRX

BIP-Reference: CN-104

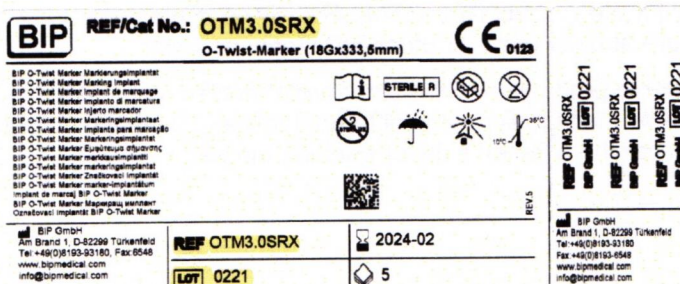
Fig.1: Example label

The corresponding LOT number can be found on the respective product packaging (see Fig.1)

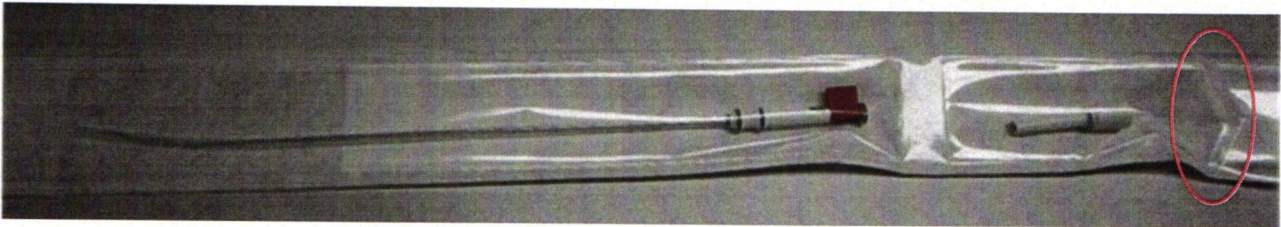
The affected sealing seam is located on the side for opening the sterile pouch, on the side with the guide sleeve (see Fig.2, red marking)

Fig.2: Product OTM3.0SRX, application cannula with implantable marking ring (left) and guide sleeve (right), separated by an intermediate sealing seam. Red marking = affected sealing seam.

As a corrective action, a change in sterile packaging for the product REF OTM-SRX will be implemented and alternative sterile pouch types shall be used, which are already used for other BIP sterile products.

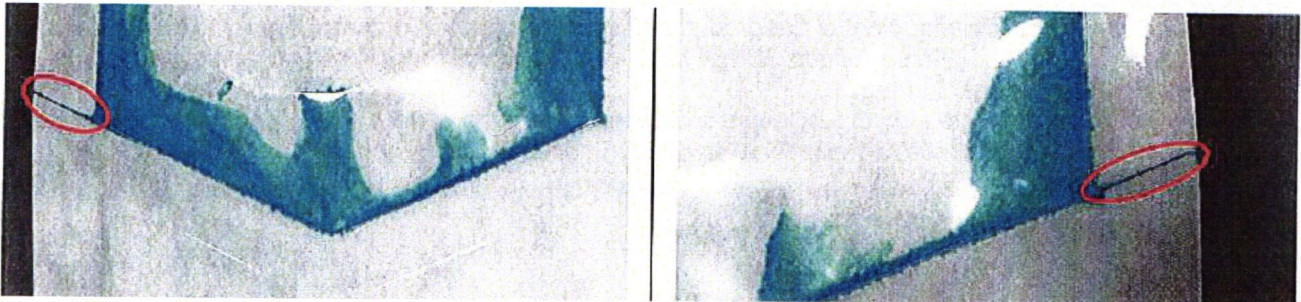
In the course of performing dye penetration tests in accordance with ASTM F1929-15 on currently used sterile peel pouches of the concerned products, it was found that in isolated cases penetration of the used test liquid can occur at a specific point of the sealing seam (see Fig. 3).

This could have the consequence that the integrity of the sterile barrier is no longer given and the sterility of the products cannot be guaranteed beyond the shelf life of 3 years as indicated on the packaging.

Fig.3: Example images of the penetrated sealing seam (red marking)

The root cause was clearly identified as a defect at the supplier's sealing tool, which is used for this transverse sealing seam. So far, only one series batch has been produced with the defective tool and it could be proven on the basis of the performed tests that the defect only appeared in a few sterile pouches.
