Cressier, 27 October 2021

## Field Safety Notice / FSCA 003-21

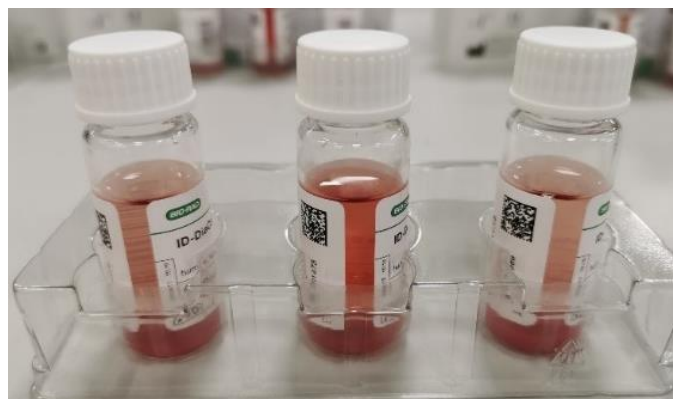
Further to customer reports, we have been able to confirm that marked hemolysis can be observed with the ID-DiaCell I-II-III and ID-DiaCell IP-IIP-IIIP lot 52 1, particularly with the cell II and IIP.

This marked hemolysis may interfere with the automatic reading and lead to a “?” result instead of negative.

Figure 1\_Image of the impacted lot of cells

- Stop using the impacted lot 45184 **52 1** and 45194 **52 1**
- Start using the new lot 45184 **69 1** and 45194 **69 1** that you have received within your standing orders.
