Urgent Field Safety Notice

Product name: balanSys REV Stem Screw

FSCA ID N2: FSCA 22/01

Type of action: **Field Safety Notice:**
Reminder to all customers of the balanSys Revision System to follow the surgical technique to ensure correct implantation of the balanSys REV Stem Screw

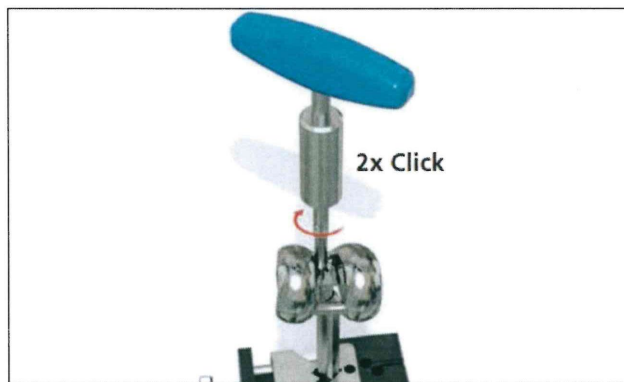
Figure 1: The screw must be tightened with the torque wrench included in the scope of delivery

Tighten the stem screw with the Torque Wrench (18.410-RAL5002) with 2 clicks.

CD *After implantation, the stem screw must be re-tightened since the screw can loosen during impaction!*

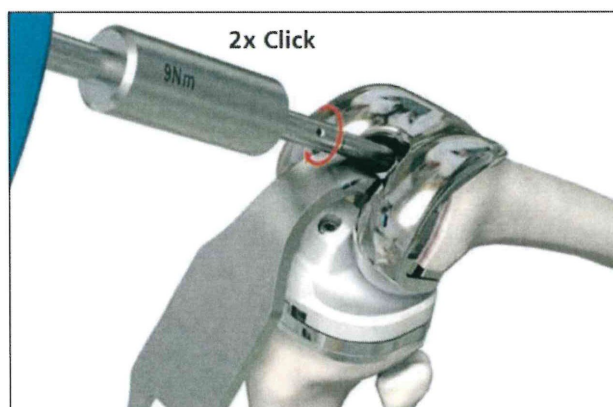
Postoperative screw loosening may be caused by failure to follow the surgical technique of the balanSys Revision System, which indicates that the balanSys REV Stem Screw must be retightened after insertion of the implant with the impactor, as the previously applied pre-tension may have been reduced by the hammer strokes.

Figure 2: After insertion of the implant with the impactor, the screw must be tightened again

Insert the Neck Stopper Curved (79.02.0750) into the box of the femur component.

Tighten the stem screw of the component with the Torque Wrench 3.5 with 2 clicks while counteracting the torque with the Neck Stopper Curved (79.02.0750).

CD *After implantation, the stem screw must be re-tightened with the Torque Wrench (18.410-RAL5002) with 2 clicks.*
