syngo.via RT Image Suite running on servers with syngo.via VB60 software after upgrade CT scanners with syngo.CT VA40A after upgrade

Customer Safety Advisory Notice CT004/22/S

Subject: Silent change of default Patient Marking workflow setting after upgrading to new RT Image Suite version with syngo.via VB60 or syngo.CT VA40 software

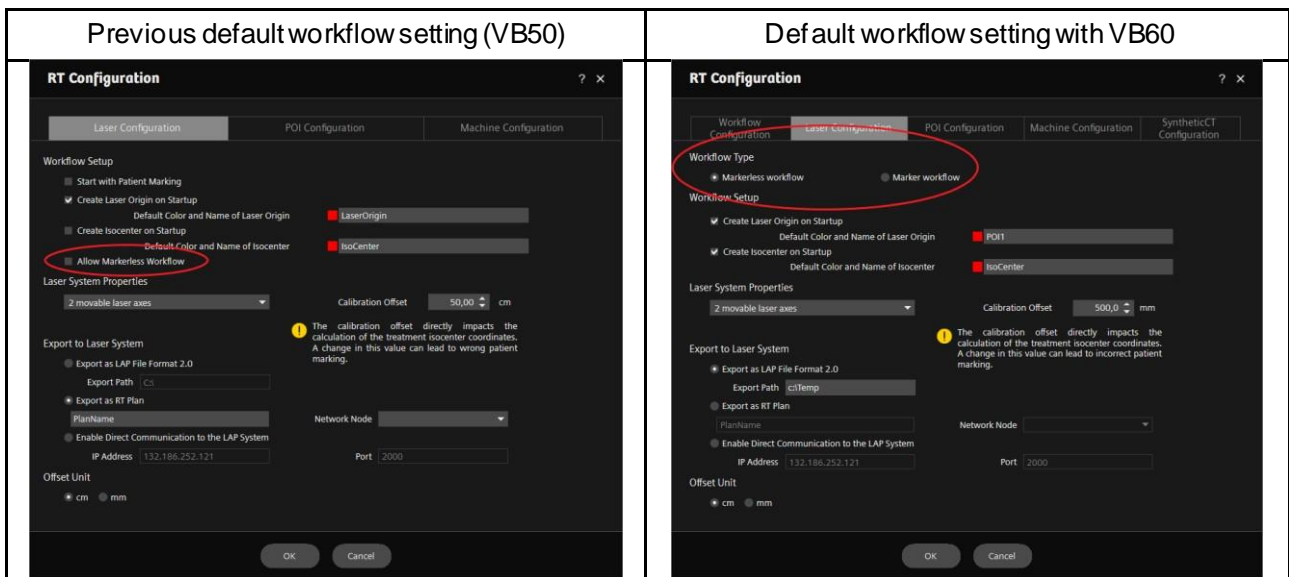
In RT Image Suite versions prior to syngo.via VB60 / syngo.CT VA40, the Workflow Setup “Allow Markerless Workflow” was deactivated by default in the Laser Configuration settings (c.f. fig.1 below, left column). After upgrading RT Image Suite to VB60, this setting is automatically, and without explicit notification, changed to “Markerless workflow” in the new “Workflow Type” section in the Laser Configuration settings with VB60 (c.f. fig. 1 below, right column).

Fig. 1: Comparison of default workflow setting in VB60 and previous versions (example: VB50).

If a marker-based workflow was used prior to the upgrade, then following the upgrade the laser offset coordinates in the Patient Marking step are no longer calculated based on the marker position. If the radiopaque markers are not placed at the laser zero position as described in the "Instructions for Use" (IFU), this may lead to the wrong laser offset coordinates being displayed in the Patient Marking step.

After upgrading RT Image Suite to VB60, please check the Laser Configuration settings in the RT Configuration and adjust the Workflow Type according to your actual workflow. Additionally, it is generally recommended that you "perform a quality assurance procedure after any change to the external laser system or any change to the software application" (c.f. IFU chapter 2.6 and 4) to ensure that the laser coordinates are correctly calculated.

It is sufficient to check that the default Workflow Type is correct. There is no technical update needed.
