Field Safety Notice / FSCA 001-23

We would like to share with you, and your team, information about an issue that could be observed on the blood grouping analyzer **IH-1000 software version 04.08.11** intended to be used with the Data Management Software IH-Com version 5.2.5 Service Pack.

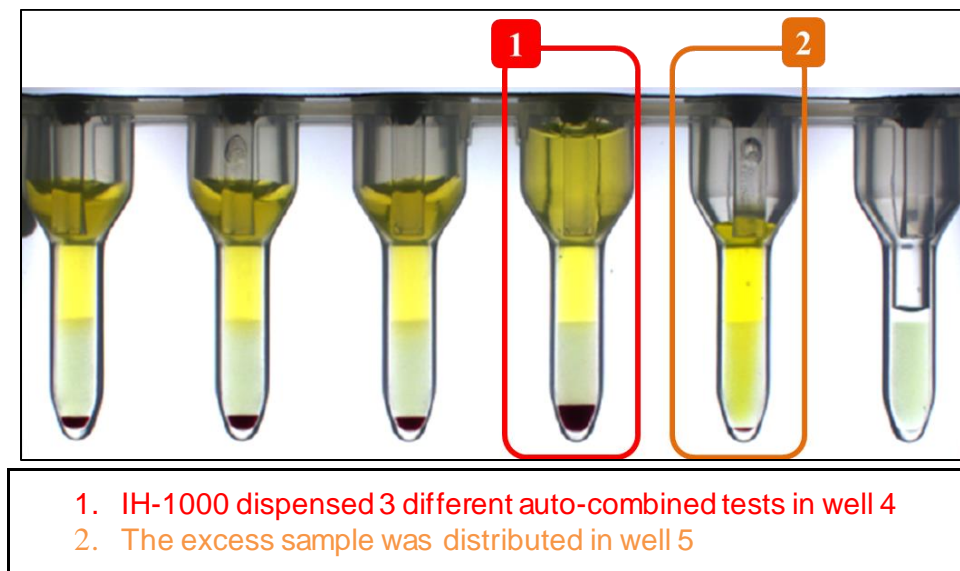
When these conditions are fulfilled, separate tests (requested by IH-Com) will be treated as auto-combined tests (execution of PR80D / PR80E / PR80F / PR80H / PY80D) by IH-1000 and samples from the same patient and different donors might be incorrectly dispensed in the same well instead of separated wells (see example in Figure 1).

Once the tests are processed, the IH-Com displays the same well for all crossmatch results.

Figure 1_Example of misdistribution of the auto-combined test
