URGENT FIELD SAFETY NOTICE MEDICAL DEVICE CORRECTION FSCA 2249723-06/02/2023-009-C & FSCA 2249723-06/02/2023-012-C Datascope Cardiosave Hybrid and Rescue Intra-Aortic Balloon Pumps (IABP)

Issue 1: Docking/Power Battery Failure Issue 2: Poor or No ECG Signal

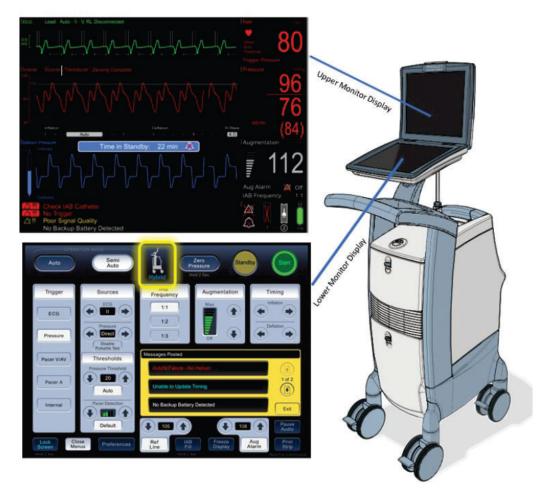
Cardiosave Upper and Lower Display

In both cases, information is provided to the user that the system is not in Hybrid mode via the Rescue Mode Icon on the bottom Cardiosave screen (top center of the screen). In addition, the "battery in use" message will be displayed in the informational message area even if the AC power cord is plugged in.

Additionally, in both scenarios, the Cardiosave will not receive AC power and if the device is in operation, it will continue to operate on battery. When the Cardiosave is not receiving AC power, the batteries are unable to charge.

If the AC Plug Icon is not present and/or the Rescue Icon is present, release the latch on the Hospital Cart located below the Pump Console, then grab the handle and slowly slide out the console approximately one quarter of the way.

Grab the handle and slowly slide the Pump Console into the Hospital Cart until it locks into place. You will hear an audible click noise and three audio tones of increasing volume will sound once the console is locked into the Hospital Cart.

To ensure the Pump Console was successfully installed into the Hospital Cart, plug the Hospital Cart power cord into a compatible grounded AC receptacle, and confirm AC operation by checking the battery icon to confirm the pump is using AC power.
