**URGENT FIELD SAFETY NOTICE
 MEDICAL DEVICE CORRECTION
 FSCAs 2249723-06/02/2023-010-C, 2249723-06/02/2023-011-C,
 2249723-06/02/2023-013-C & 2249723-06/02/2023-014-C
 Datascope Cardiosave Hybrid and Rescue Intra-Aortic Balloon Pumps (IABP)**

Product Description:	Product Code/Part Number:	UDI Code:
Cardiosave Hybrid	0998-00-0800-31 0998-UC-0800-31	10607567109053 N/A
Cardiosave Hybrid	0998-00-0800-32	10607567111117
Cardiosave Hybrid	0998-00-0800-33 0998-UC-0800-33	10607567109008 N/A
Cardiosave Hybrid	0998-00-0800-34	10607567111940
Cardiosave Hybrid	0998-00-0800-35	10607567109107
Cardiosave Hybrid	0998-00-0800-45	10607567108421
Cardiosave Hybrid	0998-00-0800-52 0998-UC-0800-52	10607567108438 N/A
Cardiosave Hybrid	0998-00-0800-53 0998-UC-0800-53	10607567108391 N/A
Cardiosave Hybrid	0998-00-0800-55 0998-UC-0800-55	10607567108414 N/A
Cardiosave Hybrid	0998-00-0800-65	10607567113432
Cardiosave Rescue	0998-00-0800-75	10607567112312
Cardiosave Rescue	0998-00-0800-83	10607567108407
Cardiosave Rescue	0998-00-0800-85	10607567113449

Distributed Affected Lot Number:	All
Manufacturing Dates:	Since December 2011
Distribution Dates:	Since March 06, 2012

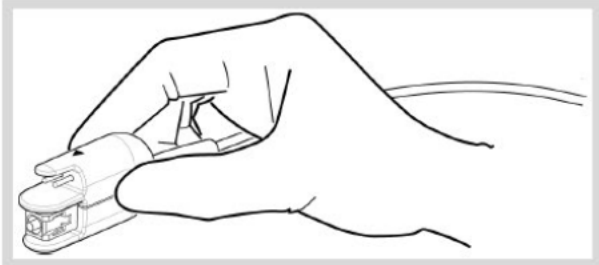
Figure 2-5: Grasping the Fiber-Optic sensor connector

The Fiber Optic connector is designed to fit smoothly into the IAB Sensor Input. The red triangle on the top of the connector should align with the red triangle on the Cardiosave console. Inserting the Fiber Optic connector into the port without verifying the correct alignment can lead to internal damage. If difficulty is encountered when inserting the connector, verify that the connector is in the correct position and attempt to reinsert into the IAB Sensor Input.

Excessive force can cause damage to the connector and the internal fiber optic assembly of the IABP console. This may cause a disruption in the fiber optic signal acquisition resulting in an inability to acquire a fiber optic signal on the Cardiosave IABP. Following proper insertion procedures will minimize the potential for damage to the connector and a loss of signal. This conclusion is based on field observations seen through the complaints evaluation. As part of Datascope's investigation testing will be performed to confirm this observation.

Damaged Fiber Optic ports may not present as an immediate failure. There is a potential for the damage to cause an intermittent or delayed failure in the Fiber Optic connection.

1. With one hand, grasp the Fiber-Optic Sensor Connector as shown in Grasping the Fiber-Optic sensor connector, with the red triangle visible on top.

Note:
Ensure that the red triangles on the Fiber-Optic IAB Sensor Connector and on the back panel are in alignment.

In step 4, when the Fiber-Optic connector is inserted into the IAB Sensor input until an audible "click" is confirmed, ensure that you are not using excessive force as that can lead to damage to the Cardiosave.
