**URGENT FIELD SAFETY NOTICE
 MEDICAL DEVICE CORRECTION
 FSCAs 2249723-06/02/2023-010-C, 2249723-06/02/2023-011-C,
 2249723-06/02/2023-013-C & 2249723-06/02/2023-014-C
 Datascope Cardiosave Hybrid and Rescue Intra-Aortic Balloon Pumps (IABP)**

Product Description:	Product Code/Part Number:	UDI Code:
Cardiosave Hybrid	0998-00-0800-31 0998-UC-0800-31	10607567109053 N/A
Cardiosave Hybrid	0998-00-0800-32	10607567111117
Cardiosave Hybrid	0998-00-0800-33 0998-UC-0800-33	10607567109008 N/A
Cardiosave Hybrid	0998-00-0800-34	10607567111940
Cardiosave Hybrid	0998-00-0800-35	10607567109107
Cardiosave Hybrid	0998-00-0800-45	10607567108421
Cardiosave Hybrid	0998-00-0800-52 0998-UC-0800-52	10607567108438 N/A
Cardiosave Hybrid	0998-00-0800-53 0998-UC-0800-53	10607567108391 N/A
Cardiosave Hybrid	0998-00-0800-55 0998-UC-0800-55	10607567108414 N/A
Cardiosave Hybrid	0998-00-0800-65	10607567113432
Cardiosave Rescue	0998-00-0800-75	10607567112312
Cardiosave Rescue	0998-00-0800-83	10607567108407
Cardiosave Rescue	0998-00-0800-85	10607567113449

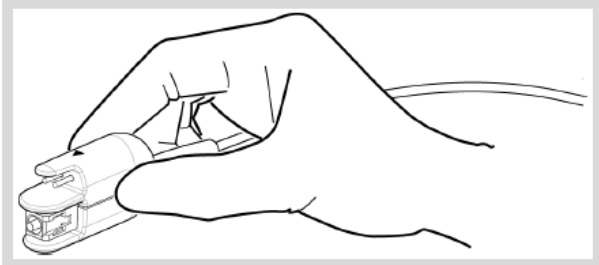
Figure 2-5: Grasping the Fiber-Optic sensor connector

Excessive force can cause damage to the connector and the internal fiber optic assembly of the IABP console. This may cause a disruption in the fiber optic signal acquisition resulting in an inability to acquire a fiber optic signal on the Cardiosave IABP. Following proper insertion procedures will minimize the potential for damage to the connector and a loss of signal. This conclusion is based on field observations seen through the complaints evaluation. As part of Datascope's investigation testing will be performed to confirm this observation.

Damaged Fiber Optic ports may not present as an immediate failure. There is a potential for the damage to cause an intermittent or delayed failure in the Fiber Optic connection.

1. With one hand, grasp the Fiber-Optic Sensor Connector as shown in Grasping the Fiber-Optic sensor connector, with the red triangle visible on top.

Note:
Ensure that the red triangles on the Fiber-Optic IAB Sensor Connector and on the back panel are in alignment.

In step 4, when the Fiber-Optic connector is inserted into the IAB Sensor input until an audible “click” is confirmed, ensure that you are not using excessive force as that can lead to damage to the Cardiosave.
