To affected users of Siemens Healthineers
MAGNETOM
 Free.Max/Free.Star/Amira/Sempra/Mica/Spectra

Customer Safety Advisory Notice MR078/23/S

Customer Information about possible artifacts from over-ear headphones during head examinations

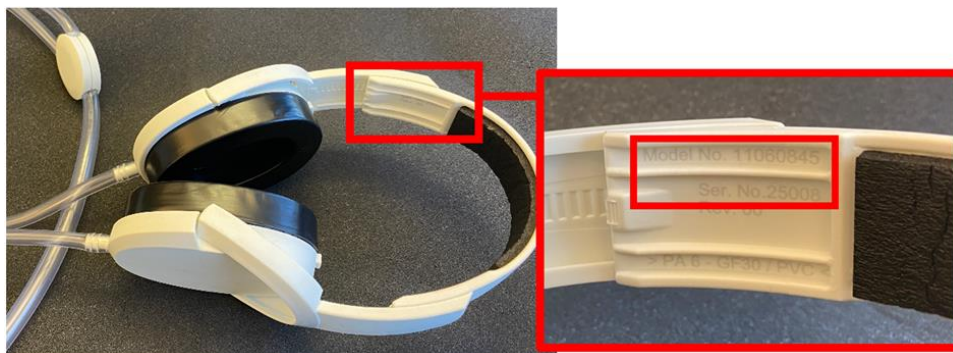
Figure 1: Location of model number and serial number on over-ear headphones

- Check the model number and serial number of your over-ear headphones. See *Figure 1* for their location on the over-ear headphones. If the model number is not identical or the serial number is outside the stated range (7981 – 32200), they are not affected.

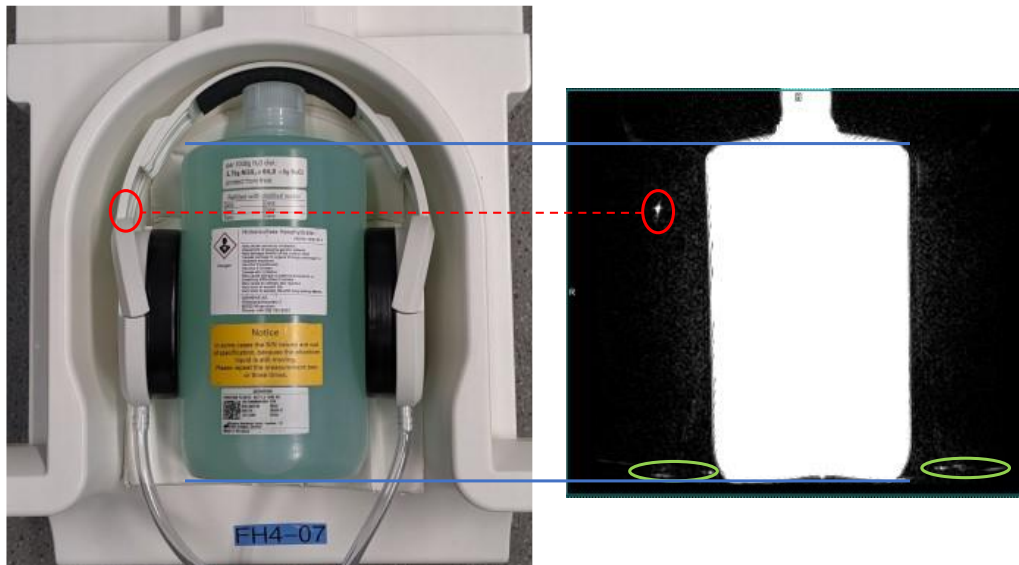
Figure 2

Left side: correct setup of phantom bottle and headphones in head coil

Right side: Example of signal from lubricating grease can be seen outside the phantom, marked with a red circle. The artifacts must be on the same height as the potential affected headbands of the headphone.

Please note: MR imaging often shows artifacts with phantom bottles in this extreme windowing e.g. at the top and/or bottom of the phantom. These artifacts are marked with green circles in the above example and can be ignored.

- **If no artifacts are visible** during the described phantom measurements, your over-ear headphones are not affected and can continue to be used for MRI head examinations.

- **If artifacts are visible** during the described phantom measurements, your over-ear headphones are affected and must not be used for head examinations. In this case, please use the built-in loudspeaker in the scanner for patient communication or, if available, in-ear headphones which are also not affected by the described issue.

Siemens Healthineers will correct the issue by exchanging the headband of the affected over-ear headphones at customer sites with the field update MR073/23/S. This replacement program will start in October 2023. With the exchange of the headband the root cause is eliminated.
