Customer Safety Advisory Notice MR072/23/S

SAFETY ADVISORY NOTICE

Customer Information about possible artifacts from over-ear headphones during head examinations

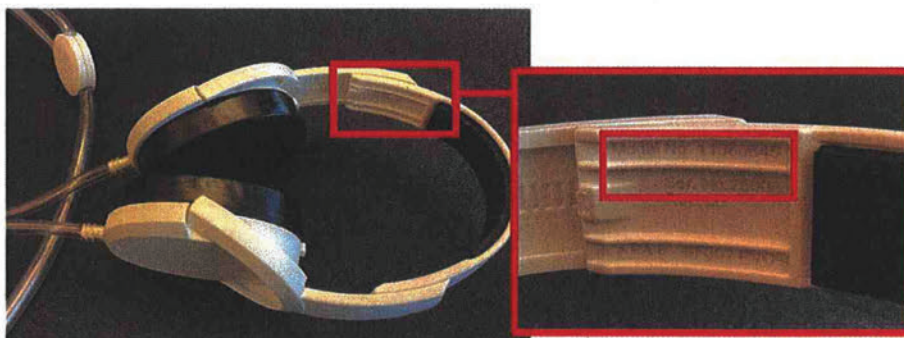
Figure 1: Location of model number and serial number on over-ear headphones

- Check the model number and serial number of your over-ear headphones. See *Figure 1* for their location on the over-ear headphones. If the model number is not identical or the serial number is outside the stated range (7981 – 32200), they are not affected.

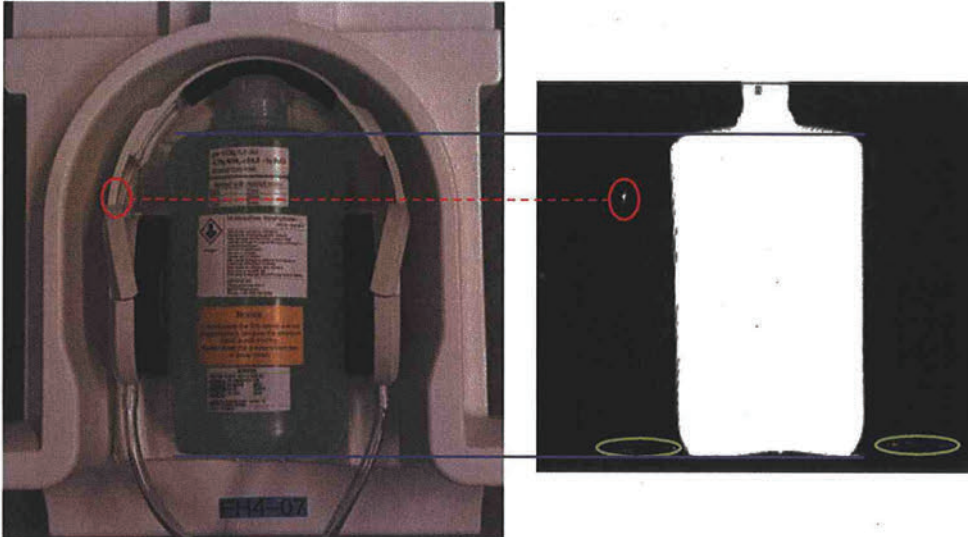
Figure 2

In some cases, when lubricating grease is present within the headband of the over-ear headphones, it may cause visible, dot- or line-shaped, fat-isointense artifacts during **head examinations only**. These potential artifacts depend on the position of the headband, the amount of lubricating grease, as well as the sequence parameters used. This issue does not impact scans of other body regions.

Siemens Healthineers became aware of this issue during post market surveillance. The root cause has been identified as a manufacturing processing error.

Left side: correct setup of phantom bottle and headphones in head coil

Right side: Example of signal from lubricating grease can be seen outside the phantom, marked with a red circle. The artifacts must be on the same height as the potential affected headbands of the headphone.

Please note: MR imaging often shows artifacts with phantom bottles in this extreme windowing e.g., at the top and/or bottom of the phantom. These artifacts are marked with green circles in the above example and can be ignored.

- ➔ **If artifacts are visible** during the described phantom measurements, your over-ear headphones are affected and must not be used for head examinations. In this case, please use the built-in loudspeaker in the scanner for patient communication or, if available, in-ear headphones which are also not affected by the described issue.

Siemens Healthineers will correct the issue by exchanging the headband of the affected over-ear headphones at customer sites with the field update MR073/23/S. This replacement program will start in October 2023. With the exchange of the headband the root cause is eliminated.
