URGENT FIELD SAFETY NOTICE THIS IS AN UPDATE TO PREVIOUSLY INITIATED ACTIONS for FSCAs

MAQUET CARDIOSAVE Hybrid and MAQUET CARDIOSAVE Rescue

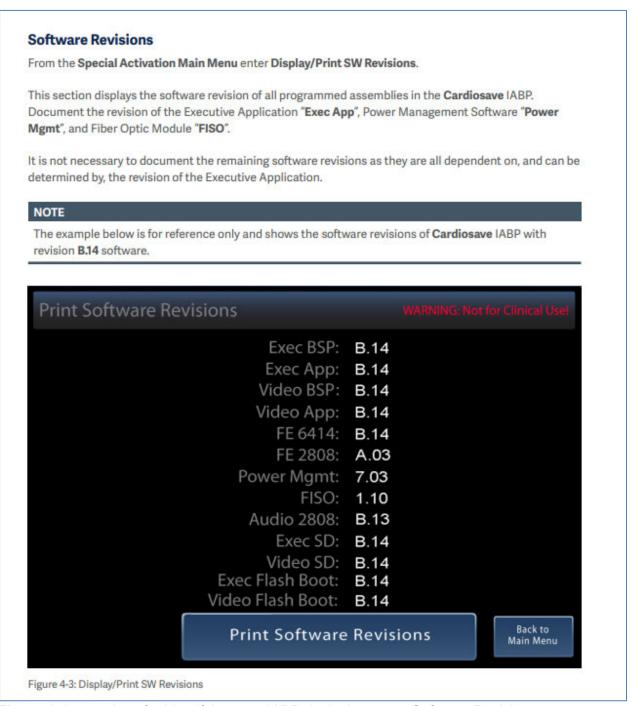
Figure 1: Instructions for identifying your IABP device's current Software Revision.

- 1. Examine your inventory immediately to determine if you have any Cardiosave Hybrid and/or Rescue IABPs.
- 2. Identify the Software Revision currently installed on your affected devices. Refer to Figure 1 below for instructions on how to identify the revision of software currently installed on your device.
 - If each of your affected devices have software revision D.00 or D.01, your devices have been corrected for purposes of the above Field Safety Corrective Actions.
 - i. Getinge/Datascope sent a separate Field Safety Corrective Action notice to customers on [date] (FSCA 2249723-11/16/2022-001-C) regarding the

potential for blood to enter into the Cardiosave Hybrid and Rescue IABPs, for which software revision D.01 was released as a correction. D.01 contains each of the corrective updates from D.00 and adds the correction for a blood back event.

• If any of your devices have software revision lower than D.00 or D.01 (e.g.: B.XX or C.XX), your device still requires the software update and has not yet been corrected.

Datascope/Getinge has developed a software correction to mitigate these issues and the software upgrade is now available. Your device may already have been corrected with this software upgrade—see below instructions to confirm your current Software Revision. If your device has not already been corrected, a Datascope/Getinge service representative will contact you to schedule the installation of the updated software. This work is being done at no cost to your facility.
