# Urgent Field Safety Notice (FSN)

**ARGUS 717V (REF 601268)**

**ARGUS 718V (REF 601349)**

**Therapy interruption / delay continuation of therapy**

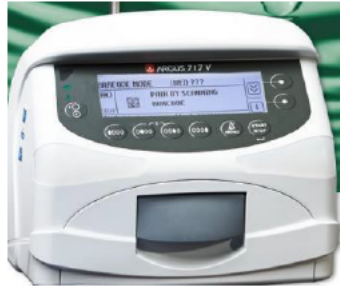
1 Information on Affected Devices	
1.1	<p><b>Device Type(s)</b></p> <p>ARGUS 717V Volumetric Pump (discontinued in 2017) and ARGUS 718V Volumetric Pump (discontinued in 2017)</p>
