FSN 524700045

FIELD SAFETY NOTICE (FSN)

Fluorocell PLT

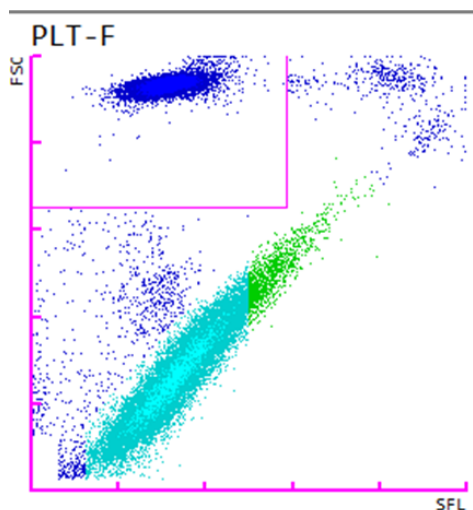
Fig. 1: Sample with a correct PLT-F classification and normal fluorescence intensity

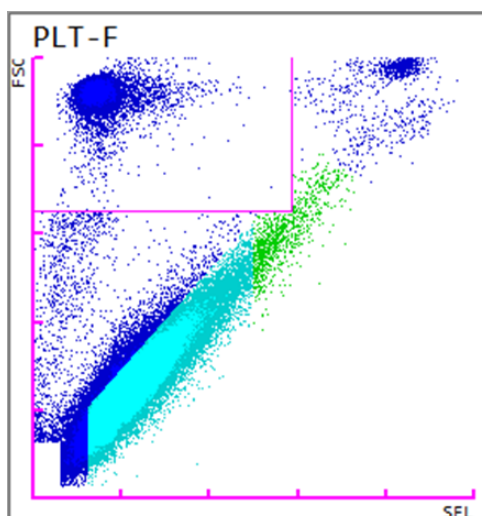
In some cases, the observed decrease was associated with an underestimation of PLT-F and IPF. The false low PLT-F value was caused by a false classification of the PLT population in the PLT-F scattergram. In the majority of these underestimated samples the flag 'PLT Abn Scattergram' was triggered.

In some cases the PLT-F population was classified as debris and thus the PLT-F results have been underestimated. This is recognisable by a dark blue coloured portion of the PLT population (please see Fig. 2). In addition, the diagnostic parameters IPF (IPF %) and IPF# (IPF count) were potentially affected as well.

Fig. 2: Sample with a PLT-F misclassification and decreased fluorescence intensity

Analyse the PLT-F scattergram for abnormalities in the classification of the PLT population, as illustrated in the example above (Fig. 2).

2. Check whether the PLT-F value is significantly lower than the PLT-I value, thereby potentially affecting clinical decisions.
3. If such a significant difference is observed causing a clinical impact, please consider whether the PLT-I value can be used, after verifying the PLT-I histogram. Alternatively, if PLT-O is calibrated, the PLT-O value can be used after verifying PLT-O scattergram (please verify with your local Sysmex representative if PLT-O has been calibrated on your analyser).
4. If during the plausibility check PLT-I, PLT-O and PLT-F values are questionable, perform a smear or measure PLT with the backup system available in your laboratory. For example if PLT-I and/or PLT-F are marked unreliable (*), and the PLT-I histogram and PLT-F scattergram are both abnormal, please verify results with the backup method defined in the laboratory's SOP.

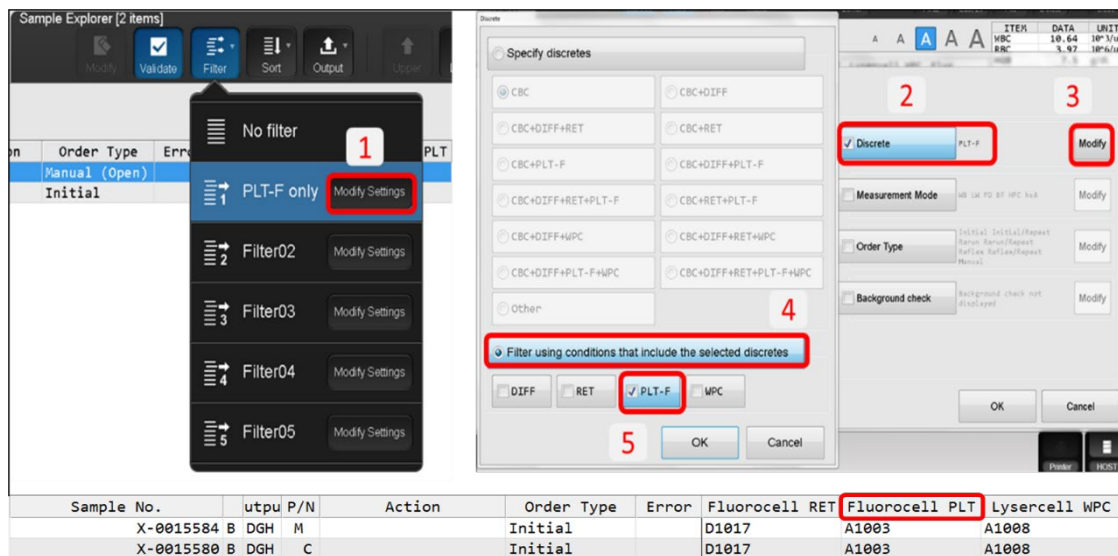
Fig. 3: Filtering of samples with PLT-F measurements. The Fluorocell PLT lot can be seen in the 'Reagent' tab for each measurement

Samples can be easily filtered in the sample explorer to focus on measurements with PLT-F, and samples with 'affected reagent lots' can be identified by using the 'Reagent' tab (see Fig. 3).
