URGENT FIELD SAFETY NOTICE

Leica M525 F40 Surgical Microscopes

FSCA-Identifier: CAPA-2017-05-001-H

Adherence to Warnings required during Transportation and Positioning in the OR of the M525 F40

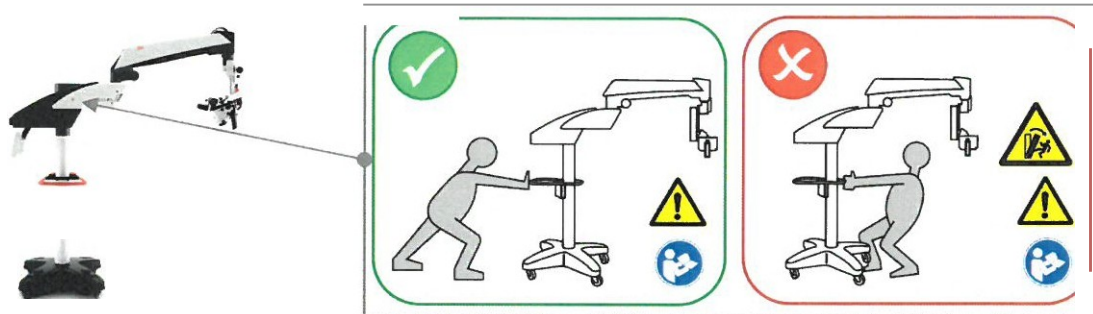
New, additional warning stickers for positioning in the OR (i.e. for minor distances, e.g. within a room):

Picture 1a: M525 40 in use position

Picture 1b & 1c: Warning labels for Leica M525 F40 positioning in the OR (new, in addition)

This is to inform you that Leica Microsystems has introduced additional warning stickers on the Leica M525 F40 (refer to picture 1a, 1b, 1c). In addition, Leica Microsystems provides a "quick reference guide for transportation and positioning in the OR" for the M525 F40 which can be attached to the instrument (refer to Appendix 1).

You can continue to use the system according to your M525 F40 User Manual. Please ensure, that only trained staff will be using your M525 F40 in order to ensure the instrument is transported, positioned and used as intended according to the instructions for use (refer to pictures 1a, 1b, 1c and 2a, 2b).

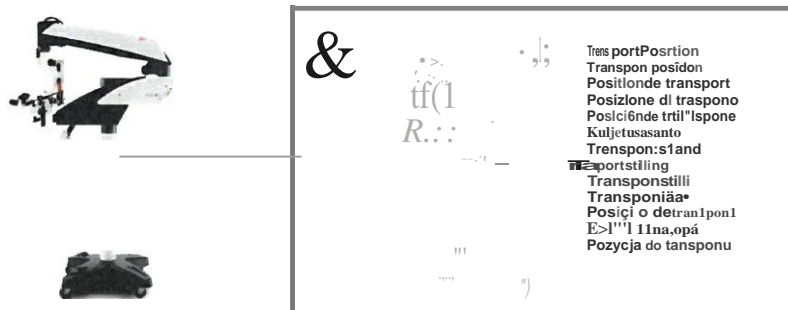
Existing warning label for transportation (i.e. over significant distances, e.g. from one room into another):

Picture 2a: M525 F40 in transport position

Picture 2b: Warning label Leica M525 F40 transport position (existing)
