## Urgent Field Safety Notice

**Commercial Name:** Delcath Systems - CHEMOSAT HDS  
**Field Safety Notice:** Delcath Complaint 002-2021  
**Type of action:** Field Safety Notice as per 4.7 of MEDDEV 2.12-1 Rev 8

**Date:** 19-Mar-2021

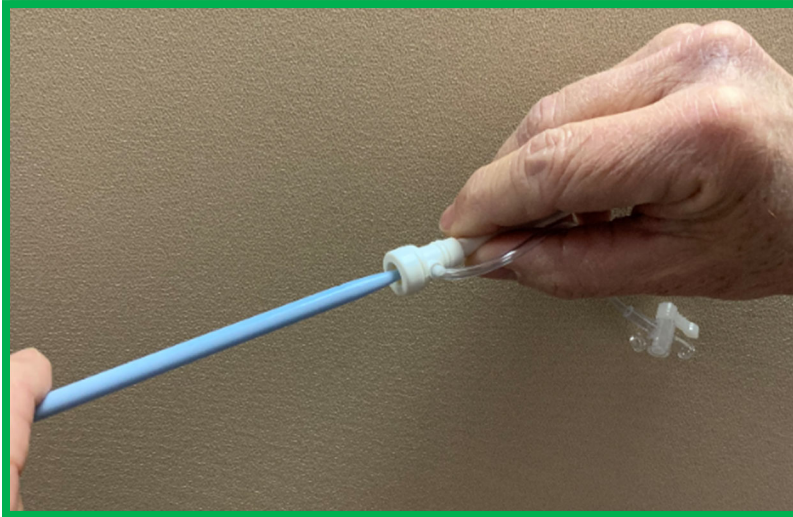
**CORRECT DILATOR INSERTION:**

The dilator, catheter and obturator should be carefully and slowly inserted into the centre of the sheath's valve. Off-centre placement or a rapid removal may damage the valve components, resulting in blood flow through the valve, as well as cause a vacuum, which may allow air to enter the sheath.

If unusual resistance is met during the dilator insertion, please slowly remove the dilator, and inspect the valve to ensure it has not been damaged or displaced. Replace the sheath, if valve damage, or valve displacement is observed.

After placement of the 18F Sheath in the femoral vein, observe for excessive blood leakage out of the sheath where the guidewire, catheter, or obturator interface, and continue to monitor throughout the treatment.
