## Urgent – Field Safety Notice

As part of NeuroLogica Corporation's continuous focus on performance and safety of our devices we have identified a potential issue that may affect the OmniTom and OmniTom Elite (NL5000) computed tomography systems.

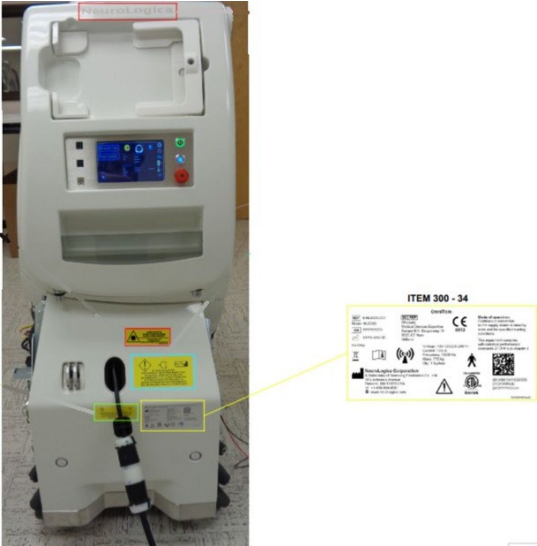
Affected Products	Device Name(s)	Serial Number/Lot Number/Reference Number
	OmniTom/OmniTom Elite (NL5000)	Unique Device Identifier (UDI) Device Identifier / Global Trade Item Number (GTIN) <ul style="list-style-type: none"> <li>• 10815411020335</li> <li>• 10815411020663</li> </ul>
<b>How to Identify Affected Products</b>	<p>The system label is located near the main input plug or on the side of the system.</p>

<p>Identification of impacted systems can be found by locating the serial number on your device. Please refer to the above image for where label is found on the device. Once you have identified the serial number on your device, please complete the Customer Reply Form at the end of this notification, noting the serial number, and return to the referenced email address.</p>	
<b>Description of Problem</b>	<p>NeuroLogica Corporation has recently become aware of a potential issue related to the operational state of the scanner, specifically for the transport wheels loosening over time with use of the device. This could lead to the inability the effectively drive the device, further leading to a potential delay in patient treatment.</p> <p>Additionally, we were made aware by our battery vendor that certain serial numbers of the batteries used to power the NL5000 device contain contaminated boards, which may impact the ability to power on the device. Again, this could lead to delay for patient treatment.</p>
