URGENT: FIELD SAFETY NOTICE

Medima infusion Sets used with Large Volume Infusion Pumps

2 August 2023

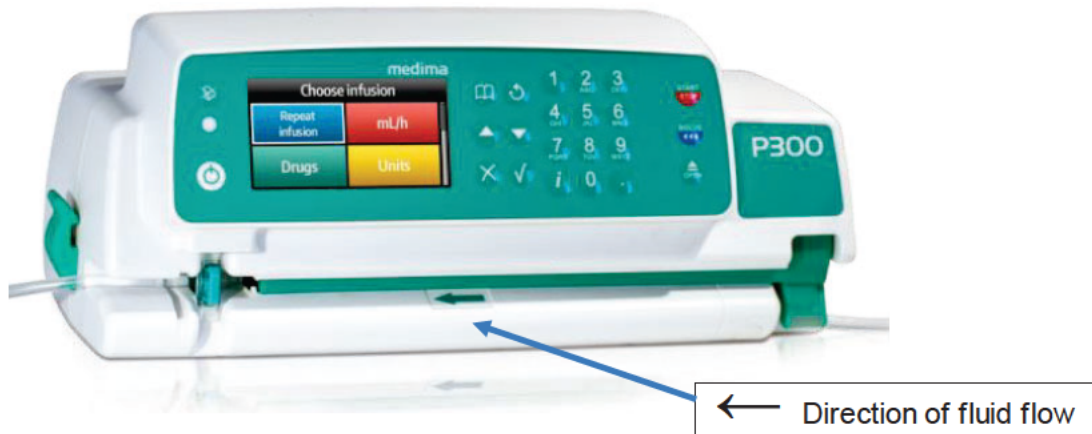
NOTE: The direction of fluid flow is indicated by an arrow just below the pump mechanism as shown below and on the instructions on the pump screen.

To ensure the correct installation of the FFPC, the spike should be on the right of the pump and the patient connector on the left of the pump.
