FSN Ref: 2021-01 (01)
Date: 21.JAN.2021

Urgent Field Safety Notice
Mölnlycke® Procedure Trays & Single Packed Sterile Trocars

Urgent Field Safety Notice (FSN)
Mölnlycke® Procedure Trays & Single Packed Trocar
Protective flanges coming away from trocar cannula

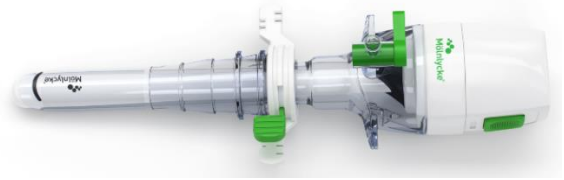
Trocar Bladeless Dilating Tip 11mm 100mm, Mölnlycke component code 2319408-00,
Trocar Bladeless Dilating Tip 12mm 100mm, Mölnlycke component code 2319447-00.

Trocar Hasson 11mm 100mm, Mölnlycke component code 2319444-00,
Trocar Hasson 12mm 100mm, Mölnlycke component code 899307-02, 2319445-00

At the point of use the user is required to **remove affected components** from the Mölnlycke® Procedure tray and **destroy them**.

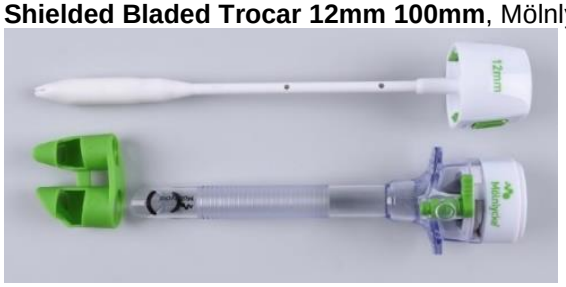
Optical Trocar 11mm 100mm, Mölnlycke component Code : 2319464-00
Optical Trocar 12mm 100mm, Mölnlycke Component Code: 2319428-00
Optical Trocar 12mm 150mm, Mölnlycke Component Code: 2321494-00, 899326-02

Optical Balloon Trocar 12mm 100 mm, Mölnlycke component code 2321500-00

Universal Trocar Cannula 11mm 100mm, Mölnlycke component code 2319466-00
Universal Trocar Cannula 12mm 100mm, Mölnlycke component code 2319467-00

Shielded Bladed Trocar 12mm 100mm, Mölnlycke component code 2319424-00
