Urgent Field Safety Notice

**Ambu AuraGain
December 9, 2015**

Ambu® AuraGain™ - Single Use Laryngeal Mask - Sterile

Lack of Sterility Assurance.

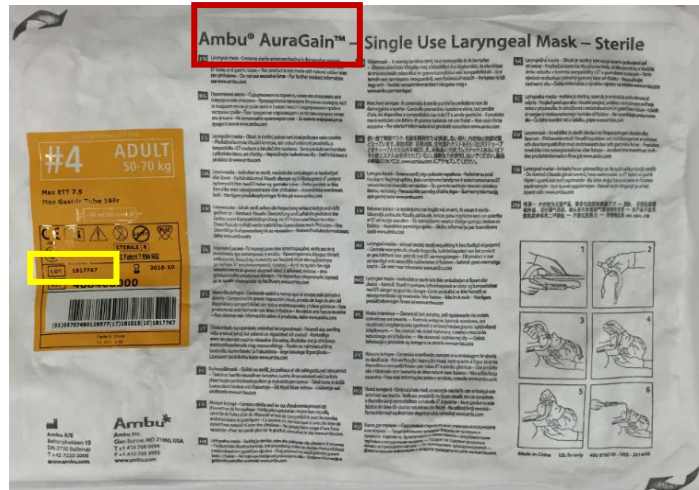
Follow these instructions to identify the AuraGain devices that may have a broken sterile barrier.

Please see picture to the right for positive identification of the device:

Note identification of device name highlighted with red box, and identification of LOT number highlighted with yellow box
