Subject: **URGENT FIELD SAFETY NOTICE - REMOVAL**

Reference: ZFA2019-00062

Affected Product: Pulsavac® Plus Wound Debridement System and Pulsavac® Plus AC Wound Debridement System

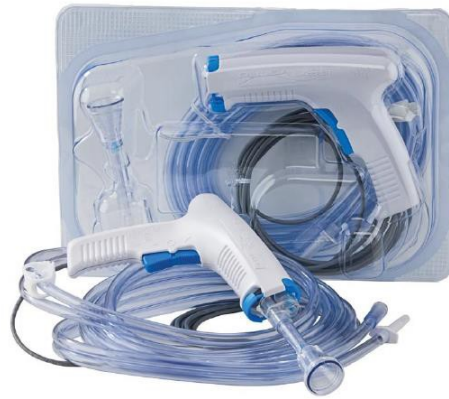
Zimmer Surgical, Inc. is conducting a medical device Field Safety Corrective Action (removal) for lot specific Pulsavac® Plus Wound Debridement Systems and Pulsavac® Plus AC Wound Debridement Systems. Following an investigation, it was determined that certain units have the potential for the tip lock to be easily dislodged and not properly secure the tip to the housing. This could lead to both the tip and the tip lock falling off of the housing resulting in delay of procedure to obtain a new device or poorly directed fluid flow with splash back.

1. Review this Field Safety Notice and ensure that affected personnel are aware of the contents.
2. If you have affected product at your facility, assist your Zimmer Biomet sales representative and quarantine all affected product. Your Zimmer Biomet sales representative will remove the affected product from your facility.
