URGENT - FIELD SAFETY NOTICE

Inspect Arrow EZ-IO® Package to ensure Safety Cap is Attached to Needle

| Commercial Name of Affected Product: | | Arrow® EZ-IO® Intraosseous Vascular Access Needle Sets 15mm Needle + Stabilizer Kit (9018P) 25mm Needle + Stabilizer Kit (9001P) 45mm Needle + Stabilizer Kit (9079P) | | |
| Teleflex Reference: | | EIF-000372 | | |

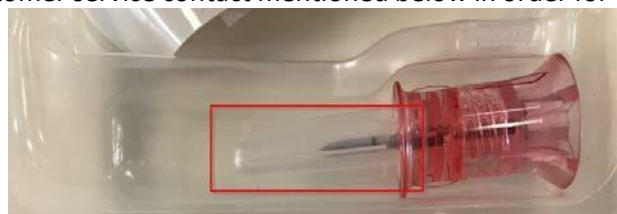
Figure 1.

Teleflex and Arrow have recently received 32 complaints reporting that the safety cap attached to needles within the EZ-IO needle sets may become dislodged exposing the needle and potentially causing the needle to protrude through the packaging. To date, there is only one reported needle stick. If this issue is not detected, the immediate risk of exposure to the affected devices is needle stick injury to the clinician or health care professional. In addition, a puncture of the packaging may compromise the sterility of the needle.

- 1.) If you have stock in inventory, visually inspect the product.
 - a. If the safety cap covers the needle, per Figure 1 below, this product is acceptable for use.
 - b. If, after inspection, you identify codes/lots as defective, please:
 - Dispose of such product locally; and
 - Inform us of the affected codes/lots by calling the phone number or emailing the customer service contact mentioned below in order for your account to be credited.

Containment: Corrective actions are being implemented at the manufacturing facility to reduce the risk of the safety cap dislodging from the needle.
