Field Safety Notice (FSN)

FSCA Number: FSCA-2019-09-10

FSCA Title: VHK and VKMO(D) Adult/Small Adult Accessories –Sterile Barrier Integrity

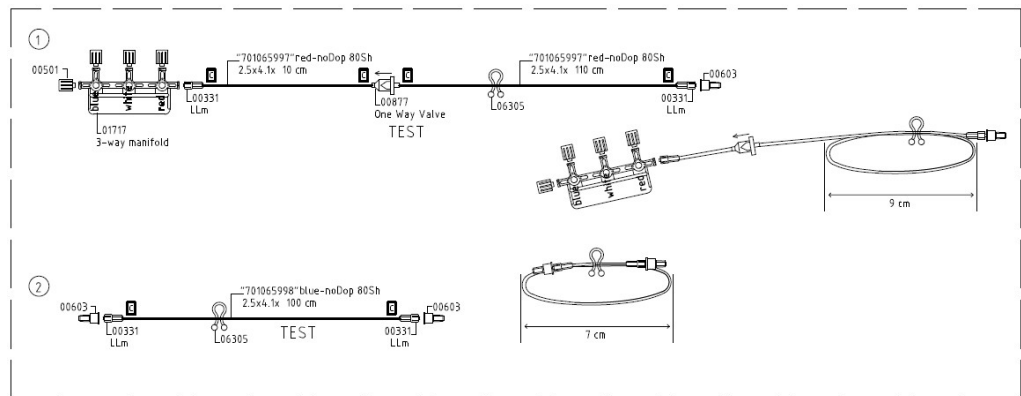
3-way manifold line

During verification testing of Adult/Small Adult VKMOs and VHK a potential impairment of the sterile packaging pouches of the accessories was detected, for products manufactured after March 4th 2019. Under unfavorable transport conditions, excessive movement of the device and its accessories in the carton can lead to stress points that could compromise the sterile barrier of the packaging pouches.

- Remove and do not use the **accessories**, 3-way manifold line, Tight caps and Adapter for recirculation line
- In case you do not want to use this product without the accessories, please return the product to your local Getinge representative
