Subject: **URGENT MEDICAL DEVICE FIELD SAFETY NOTICE - REMOVAL-LOT SPECIFIC**

Affected Product: Ringloc Acetabular Liners

Reference: ZFA 2019-00326

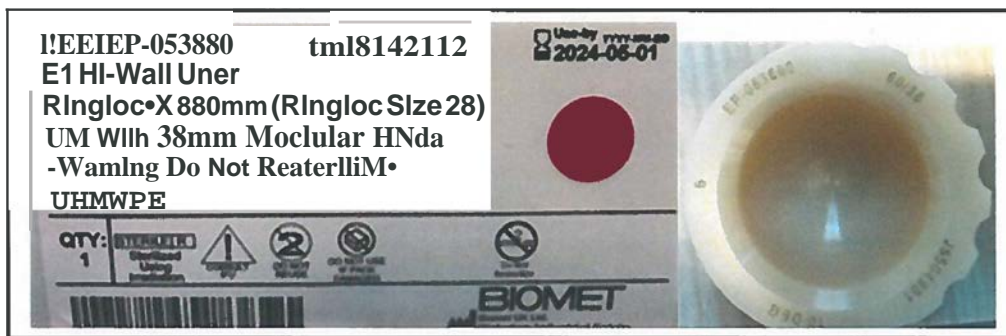
EP-053660 Ringloc-X E1 HiWall Lot number 6542112 contains EP-063660 (Ringlox-X E110 Deegree) Lot J6504901

Should the issue not be noticed when the item in the packaging labelled EP-053660 is removed from the package, then the range of motion assessment conducted by the surgeon during the procedure to ensure that all implants are positioned and aligned optimally as per surgical technique would detect any difficulties with the range of movement.

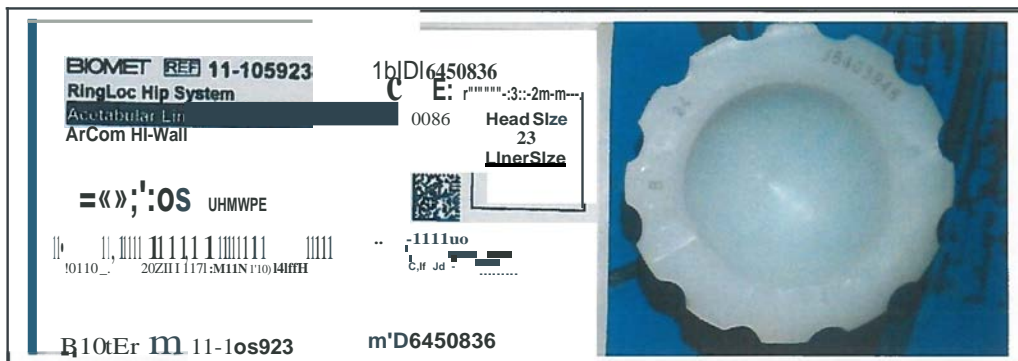
11-105923 Ringloc Liner HiWall size 23 Lot number 6450836 contains 11-105924 Ringloc Liner HiWall size 24 Lot J6403948

Should this issue not be noticed when the item in the packaging labelled 11-105923 is removed from the package, then when implanting the liner it will not fit into the shell.
