Urgent Field Safety Notice

Ambu® SPUR® II for Demand Valve

Ambu2021FA00001

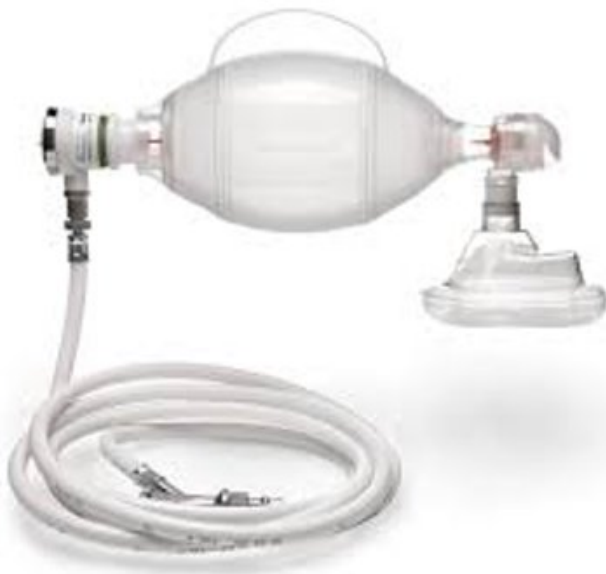
Ambu® SPUR® II for Demand Valve

Ambu has received an incident report following use of Ambu® SPUR II for demand valve from a German hospital, where the oxygen connector was found collapsed during use.

The oxygen connector on the Ambu SPUR II for demand valve can in very rare cases deteriorate during storage and present as collapsed. If a SPUR II for Demand Valve version with a collapsed oxygen connector is put into use, it will not be possible to provide the patient with additional oxygen from the oxygen reservoir. Additional oxygen can still be provided through the demand valve and ventilation with ambient air is still possible.

The traceability system at Ambu indicates that your institution has purchased the SPUR II for Demand Valve device produced between December 2014 and February 2019 and there may be affected devices in your stock. You should address this by discarding affected LOTs of the Ambu SPUR II for Demand Valve devices according to local regulations.
