**Field Action Notice for the ASP6025, Leica ASP300 S, Leica ASP200 S,  
HistoCore PEARL, HistoCore Spectra ST**

**Description of the problem:**

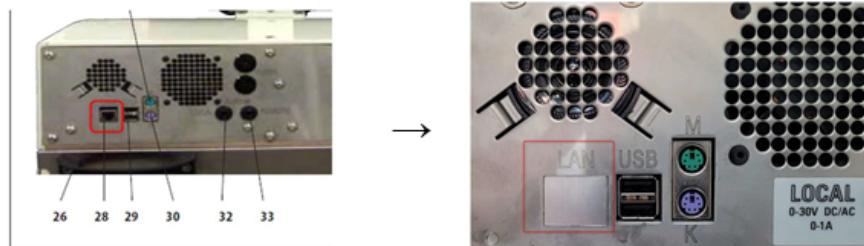
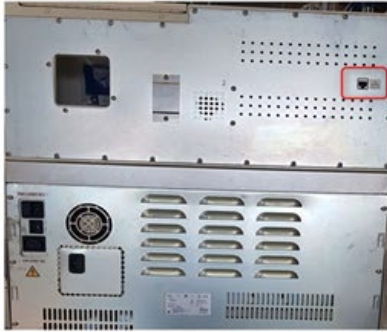
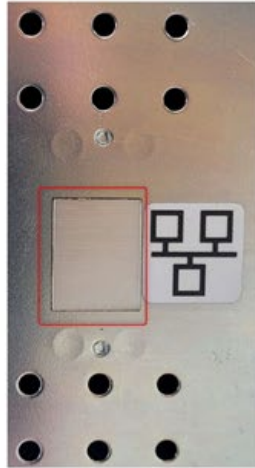
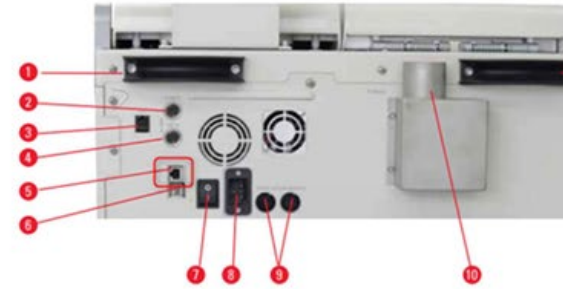
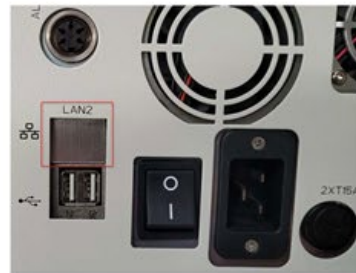
**ASP6025**

First clean the surface with alcohol based cleaner around the area where the adhesive label shall be placed (grease free). Then remove the provided enclosed label from the foil and place it on the surface as shown in the pictures below.

As an immediate action, we ask you to remove the devices from the network by unplugging the network cable and to cover the network port with an enclosed label as shown below, to prevent someone from reconnecting the device to the network.
