URGENT: FIELD SAFETY NOTICE – MDS-22-4560

BD Connecta™ Stopcock

Type of Action: Product Removal

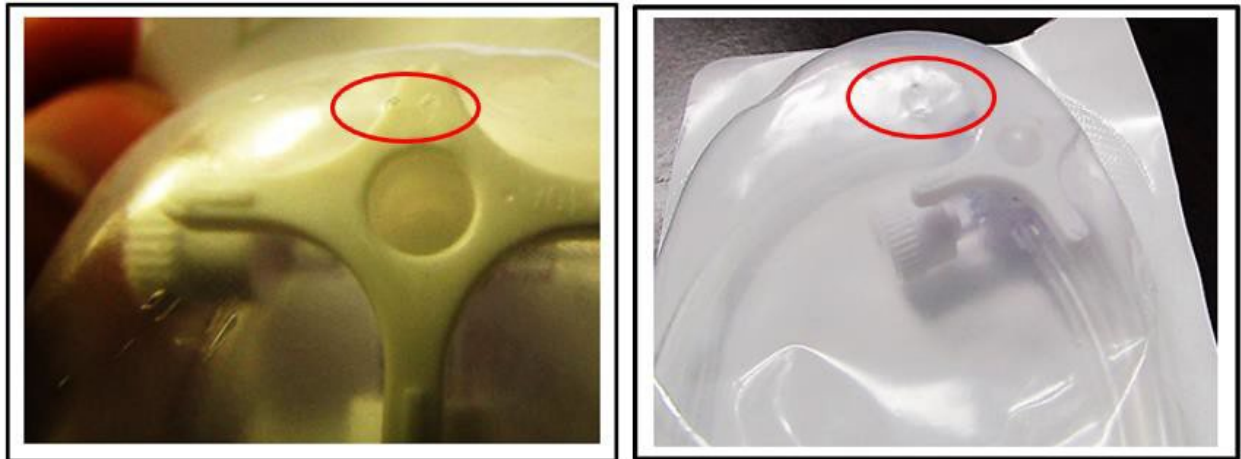
BD has identified internally that the specific product Lots (listed in Appendix 1) may present a hole or rupture in the unit blister packaging as shown in Figure 1 and 2. As a result of this potential defect the sterility of the product may be compromised.

Figure 1: Hole in the blister packaging

- Cease use of any unused affected **BD Connecta™ Stopcocks**.
- Identify and quarantine all unused affected **BD Connecta™ Stopcocks**.
- Make a note of the lot numbers and destroy all unused affected units.
- Complete and return the Customer Response Form **even if you no longer have any inventory remaining in your facility by 30th November 2022**.
- Circulate this notice to all those who need to be aware within your organization or to any organization where the potentially affected devices have been transferred.
- If you experience any issues with **BD Connecta™ Stopcock**, please report as a complaint as per your normal process.

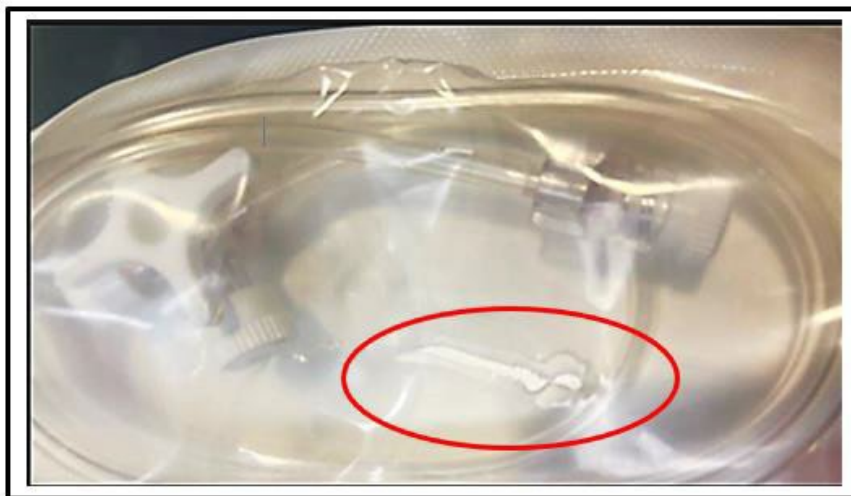
Figure 2: Rupture in the blister packaging
