FIELD SAFETY NOTICE

HHE #: HHE-002_SERSQUID_3ML Syringes broken

PURPOSE: Occurrence of crack on SERSQUID_3 syringes – part of SQUID 3ML kit

PRODUCT RANGE: SQUID_3

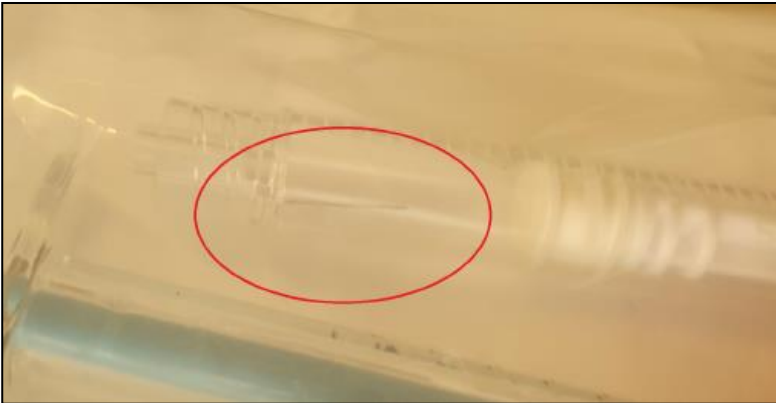
Since June 2024, we received 2 Complaints for a broken syringe (picture 2) without any patient injury. During the incoming inspection of SERSQUID_3ML syringes, part of the SQUID 3ML kit, we detected occurrences of crack on the syringe, which can lead to broken syringes. See picture 1 & 2.

Picture 1: crack on syringe body

We defined corrective actions linked to this process to avoid this defect. The pushed position of the piston (Picture 3) which favors cracking or breakage of the syringe is systematically avoided. The only position which avoid this failure is the "middle of the syringe" position (Picture 4).

Following the results of our investigations, corrective actions are in place to ensure the sending of the next syringes to the market without any risk of default.

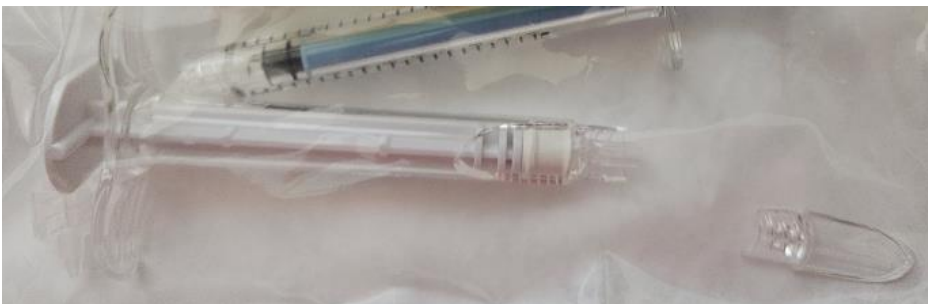
Picture 2: Broken syringe

The fissure/crack of syringes causing leakage of the liquid embolic. A full broken syringe does not allow to perform the operation. It is easily detected by the user, so it is improbable that syringe failure will cause patient injury as the leakage will be observed during use.

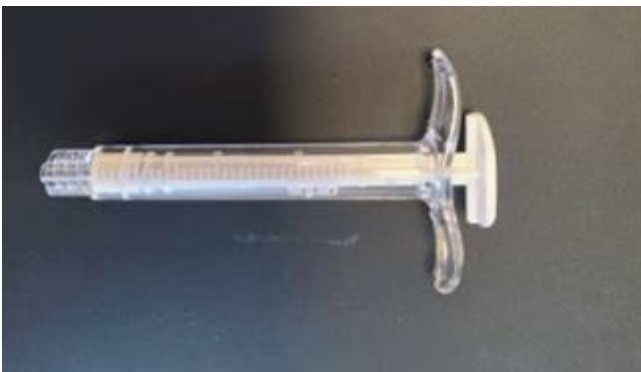
Picture 3: plunger pushed

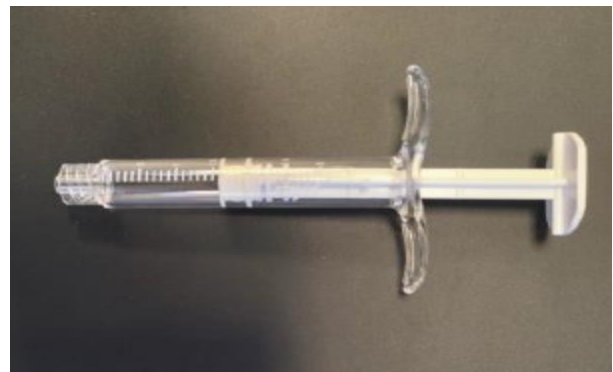
Picture 4: Plunger in middle position
